NEPA Environmental Assessment

RCO Conversion at Chesterley Park

A partial conversion of land protected under Section 6(f)(3) of the Land and Water Conservation Fund Act, Public Law 108-198

April 2017

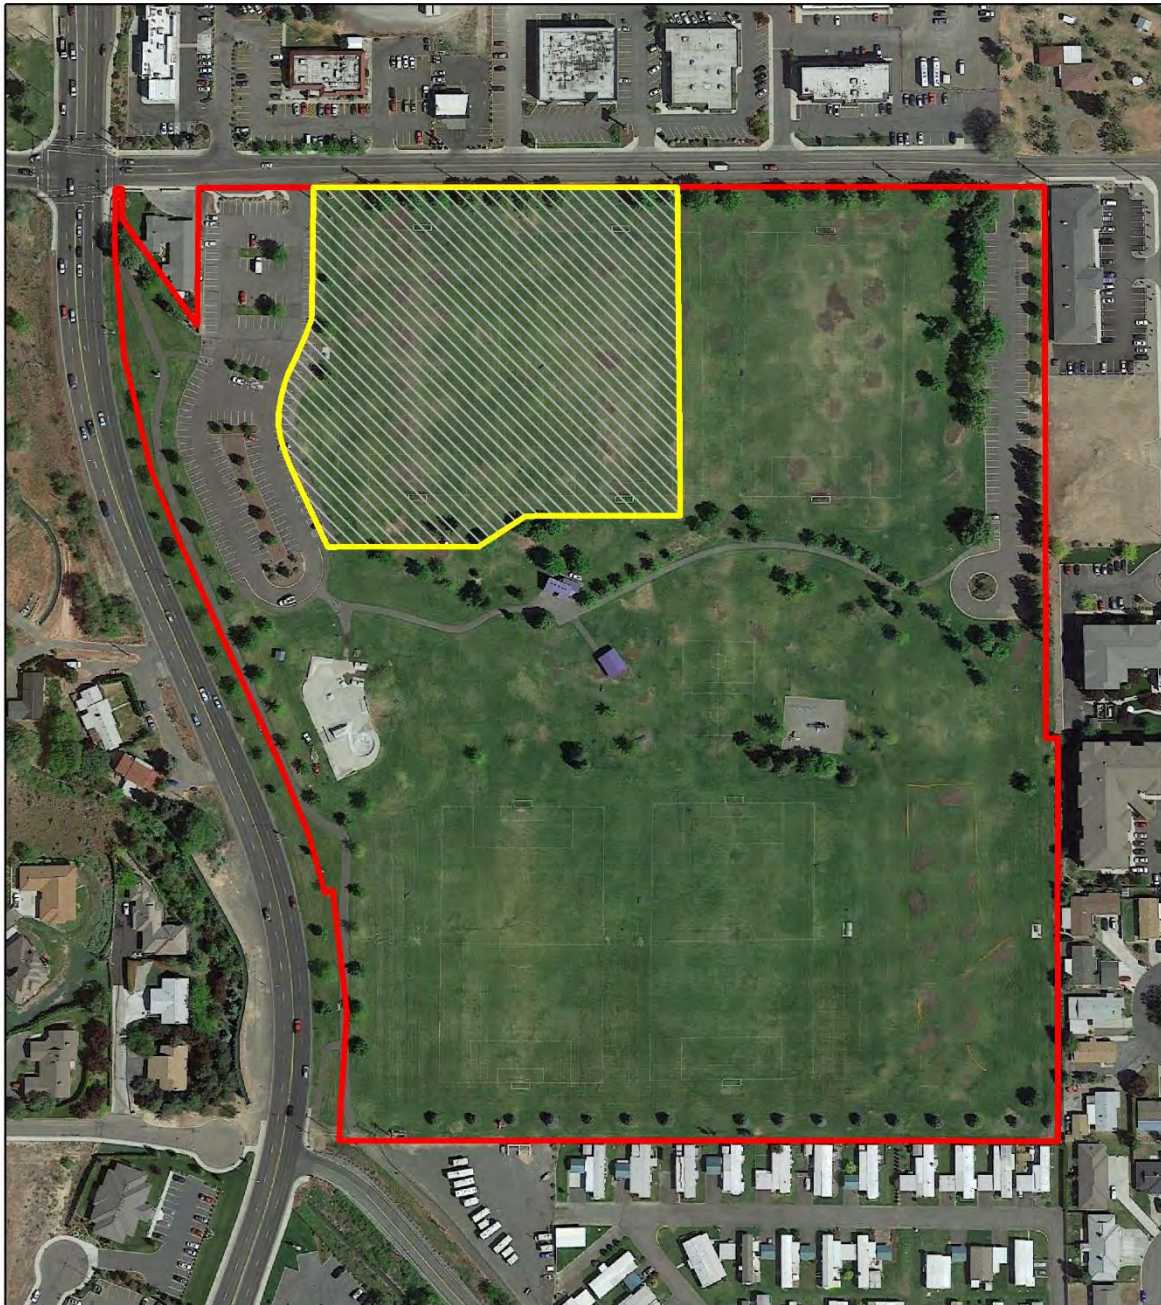
Figure 2. Chesterley Park Conversion Area

The geographic location of the existing park and proposed conversion property can be seen in Figure 1. The currently protected portion of Chesterley Park is depicted in Figure 2, which also shows the outline of the proposed conversion. Figure 3 depicts the boundary of the Chesterley Park that will remain protected by 6(f)(3) if the conversion is approved. The proposed Replacement Park area can be viewed in Figure 4.

The proposed action is to transfer federal 6(f)(3) contractual obligations from 5.59 out of 32 acres in Chesterley Park that will be replaced with a new 6(f)(3) protected 31.2-acre replacement park. The Chesterley Park conversion area can be viewed in Figure 2 and the Replacement Park area can be viewed in Figure 4. The post-conversion planned use for the property is the development of an aquatic center, attached YMCA, and additional parking facilities. It is anticipated that construction will begin in 2018. A map of the post-conversion 6(f)(3) protected park boundary can be seen in Figure 3.

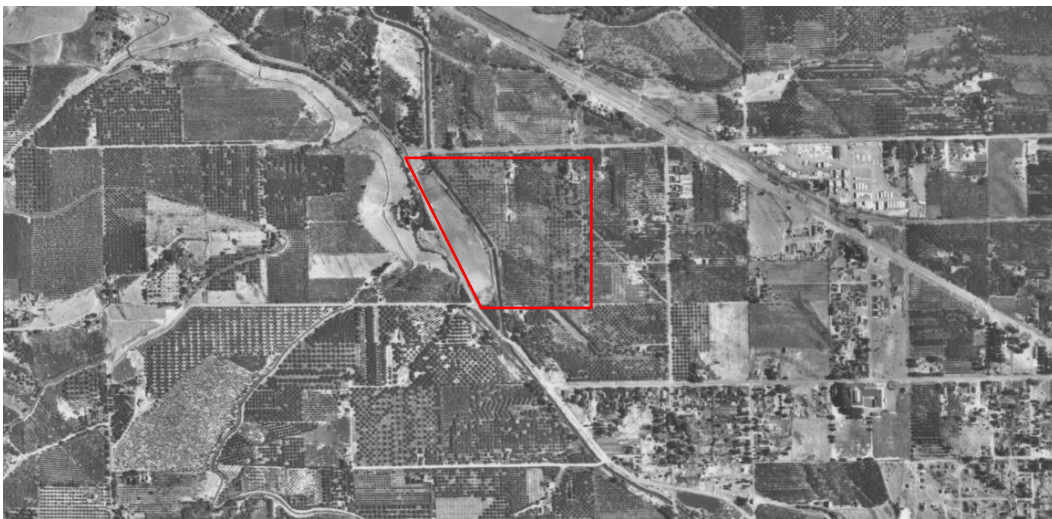
Figure 6. City of Yakima 1949 Aerial Photo with approximate Chesterley Park Boundary (CWU 1949a).

Chesterley Park is located on parcels currently zoned R-2 Two Family Residential District (Figure 7). The site had been historically used for agriculture and was once divided by the Powerhouse Canal which provided irrigation to the northern Yakima area. Historic aerial photographs depict that by 1949, City of Yakima residential properties were expanding to the eastern boundary of Chesterley Park and all land west was agricultural (Figure 6). The City has developed rapidly since this time, with residential properties now extending west for an additional four miles, particularly in the West Valley. The park is now surrounded by a combination of commercial and residential development. Agricultural land persists to the northwest up the Cowiche Creek and Naches River. The Powerhouse Canal has been removed and converted to the Powerhouse Canal Pathway which connects Chesterley Park to McGuinness Park for non-motorized uses.

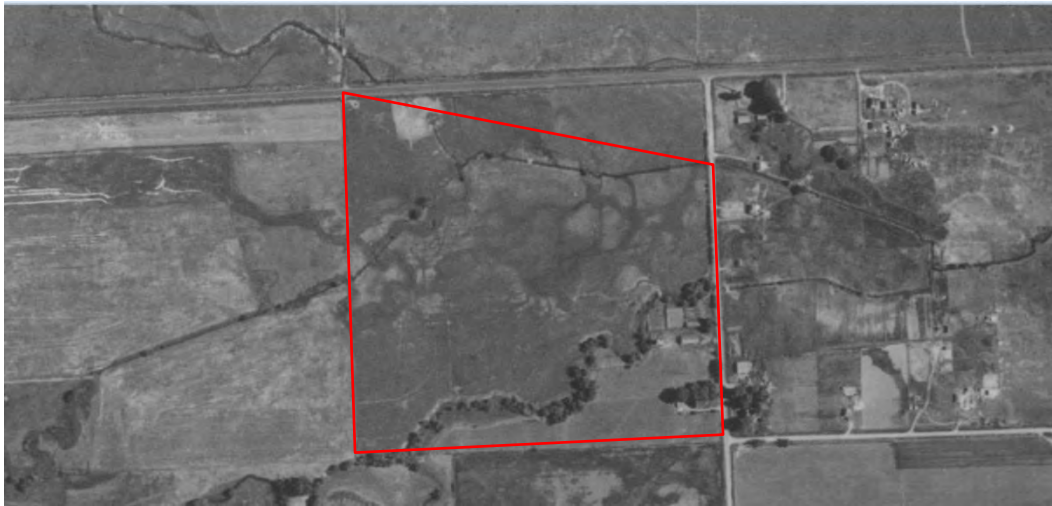
Figure 8. City of Yakima 1949 Aerial Photo with approximate Replacement Park boundary (CWU 1949b).

Historic aerial photographs dating back to 1949 indicate that the Replacement Park area was previously host to a few structures on the southeast corner and may have been used at least in part for residential or agricultural purposes (Figure 8). At this point in time, Spring Creek was aligned through the site in straight artificially-altered channels. Spring Creek also merged with another unnamed creek in the center of the property. Although it no longer exists today, the additional creek extended west through current day residential developments and has been drained or diverted. The aerial photography depicts a row of trees along the floodway (the southernmost channelized landform). The surrounding area was primarily agricultural in 1949, but much of that has given way to residential development. The property is abutting the current city limits, bordering Yakima County land. Land use in the vicinity hasn't changed significantly in the previous 20 years, although some residential development has occurred and the SOZO Sports Center is under construction .

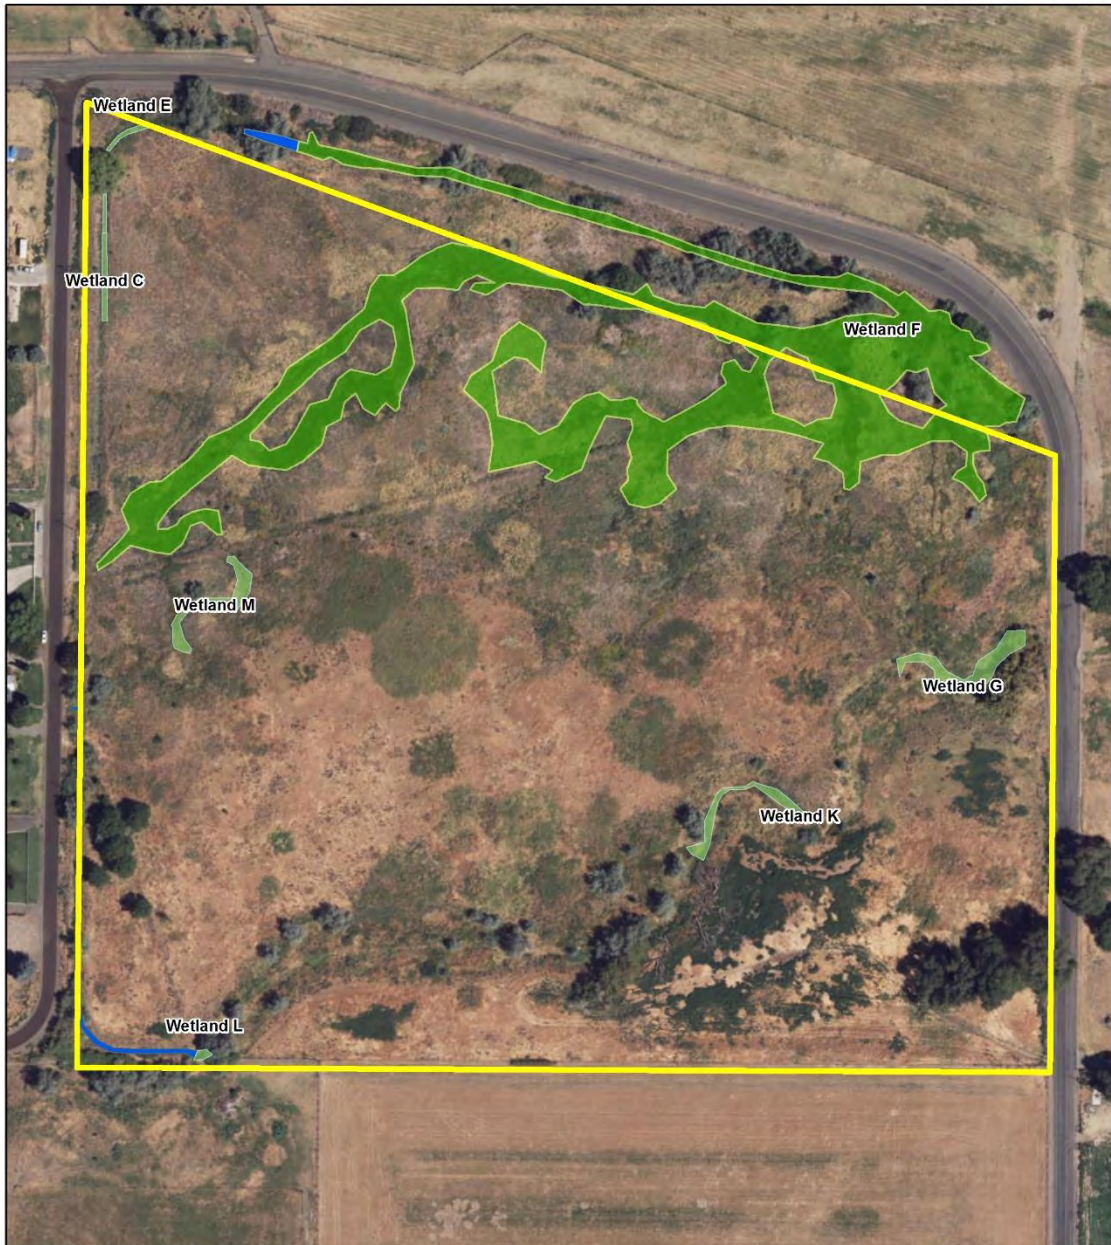
Figure 13. Delineated Wetlands

Groundwater at the Replacement Park is primarily fed by waters originating from the Cascades during periods of rainfall and snowmelt. The City of Yakima is within an arid region characterized by little overall rainfall. Groundwater is supplemented from infrequent flooding that locally elevates the water table and in small amount from participation. Ground water at this site is notably high and responsible for hydrologic input to multiple wetlands.

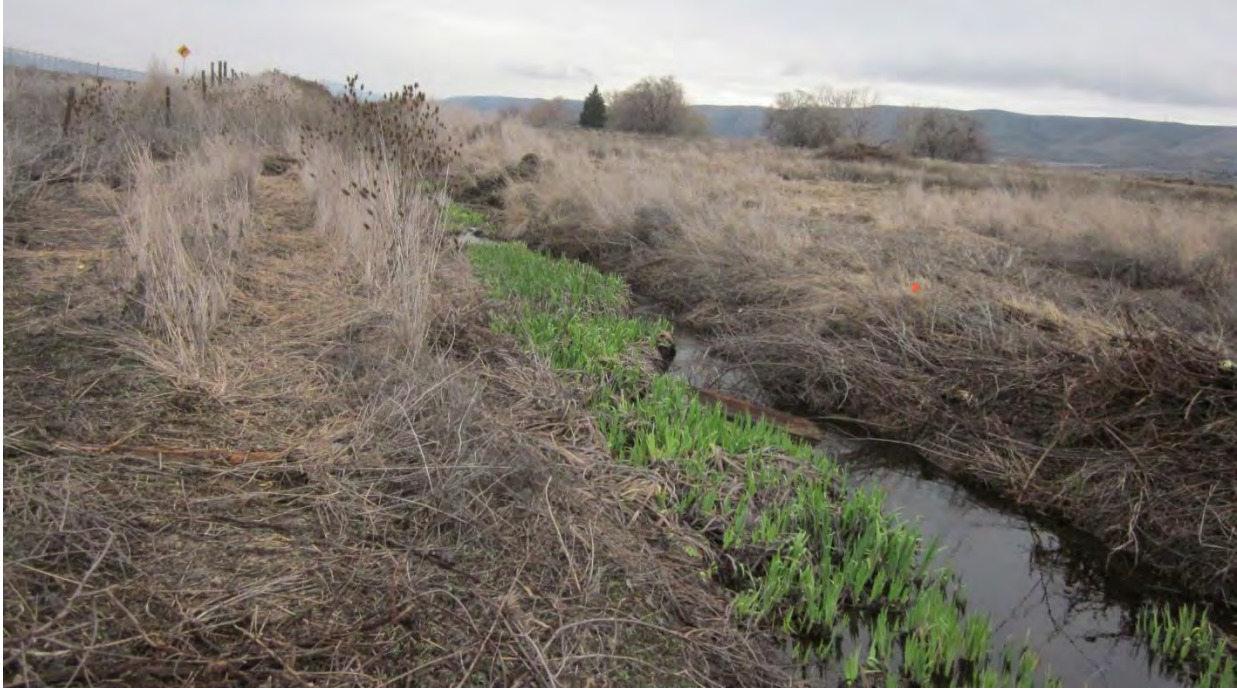
Figure 14. Spring Creek as it passes through the parcel just north of the Replacement Park. Photo taken February 19, 2016.

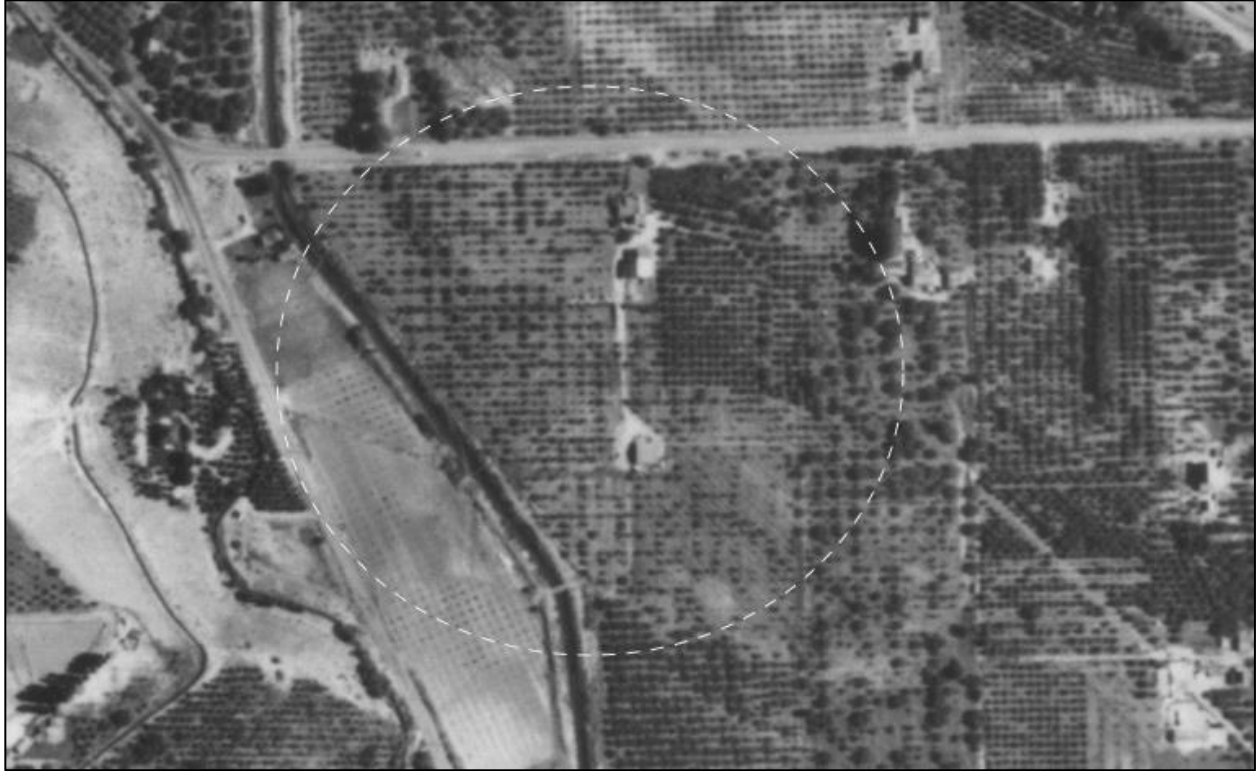
Figure 6. 1949 aerial detailing the general location of the Chesterley Park Conversion Area. Note the APE is largely orchard at this time and two buildings are present near the center of the parcel. Neither of the buildings are presently located in the APE.

buildings were located near the center of the parcel (CWU 1949) (Figure 6). Reviewed historic USGS (1958, 1961, 1974, 1985) maps identify two buildings near the northern extent of the APE (Figure 7 - Figure 9). The orchard appears to have been removed by 1985. Of the documents reviewed, Chesterley Park is not present until the 1994 historic aerial, available on the City of Yakima's GIS viewer. No buildings and/or structures are presently located in the APE.

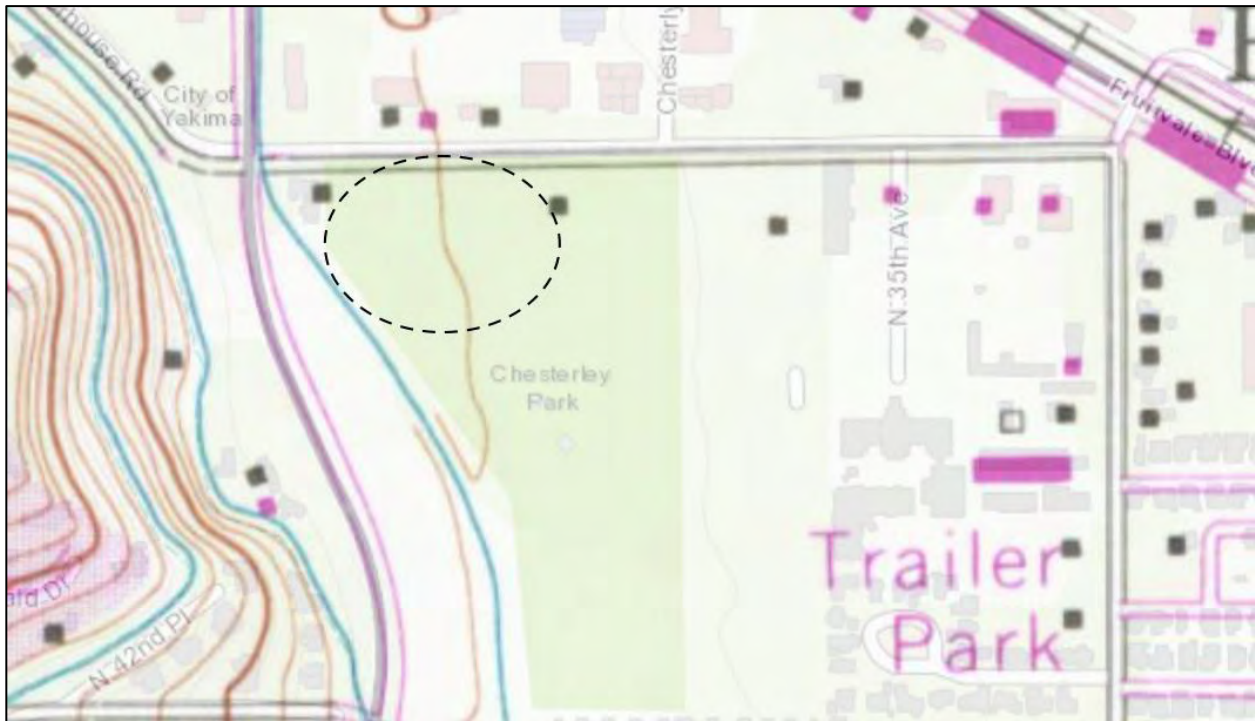
Figure 8. Portion of the 1974 USGS (overlying a contemporary map) that details the Chesterley Park Conversion Area. Note two buildings located in the northern APE are no longer present.

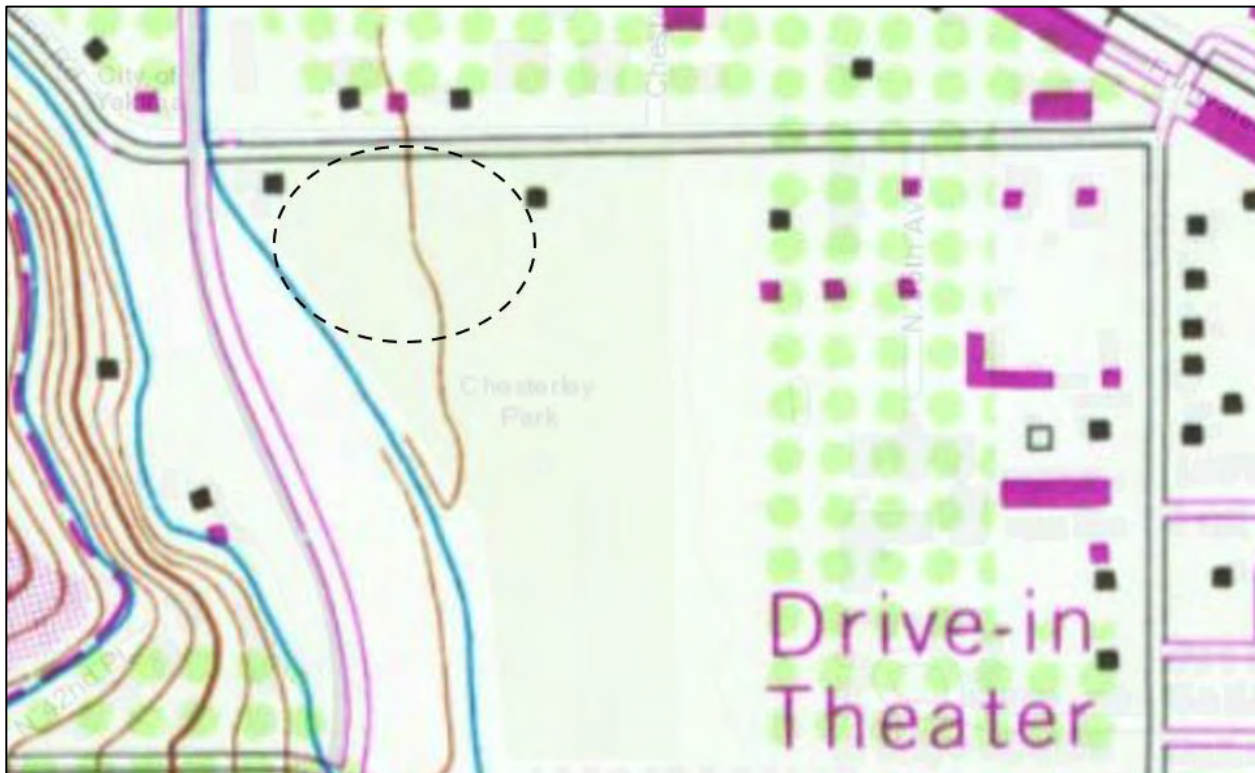
Figure 9. Portion of the 1985 USGS (overlying a contemporary map) that details the Chesterley Park Conversion Area. Note the location of buildings that are not present today.

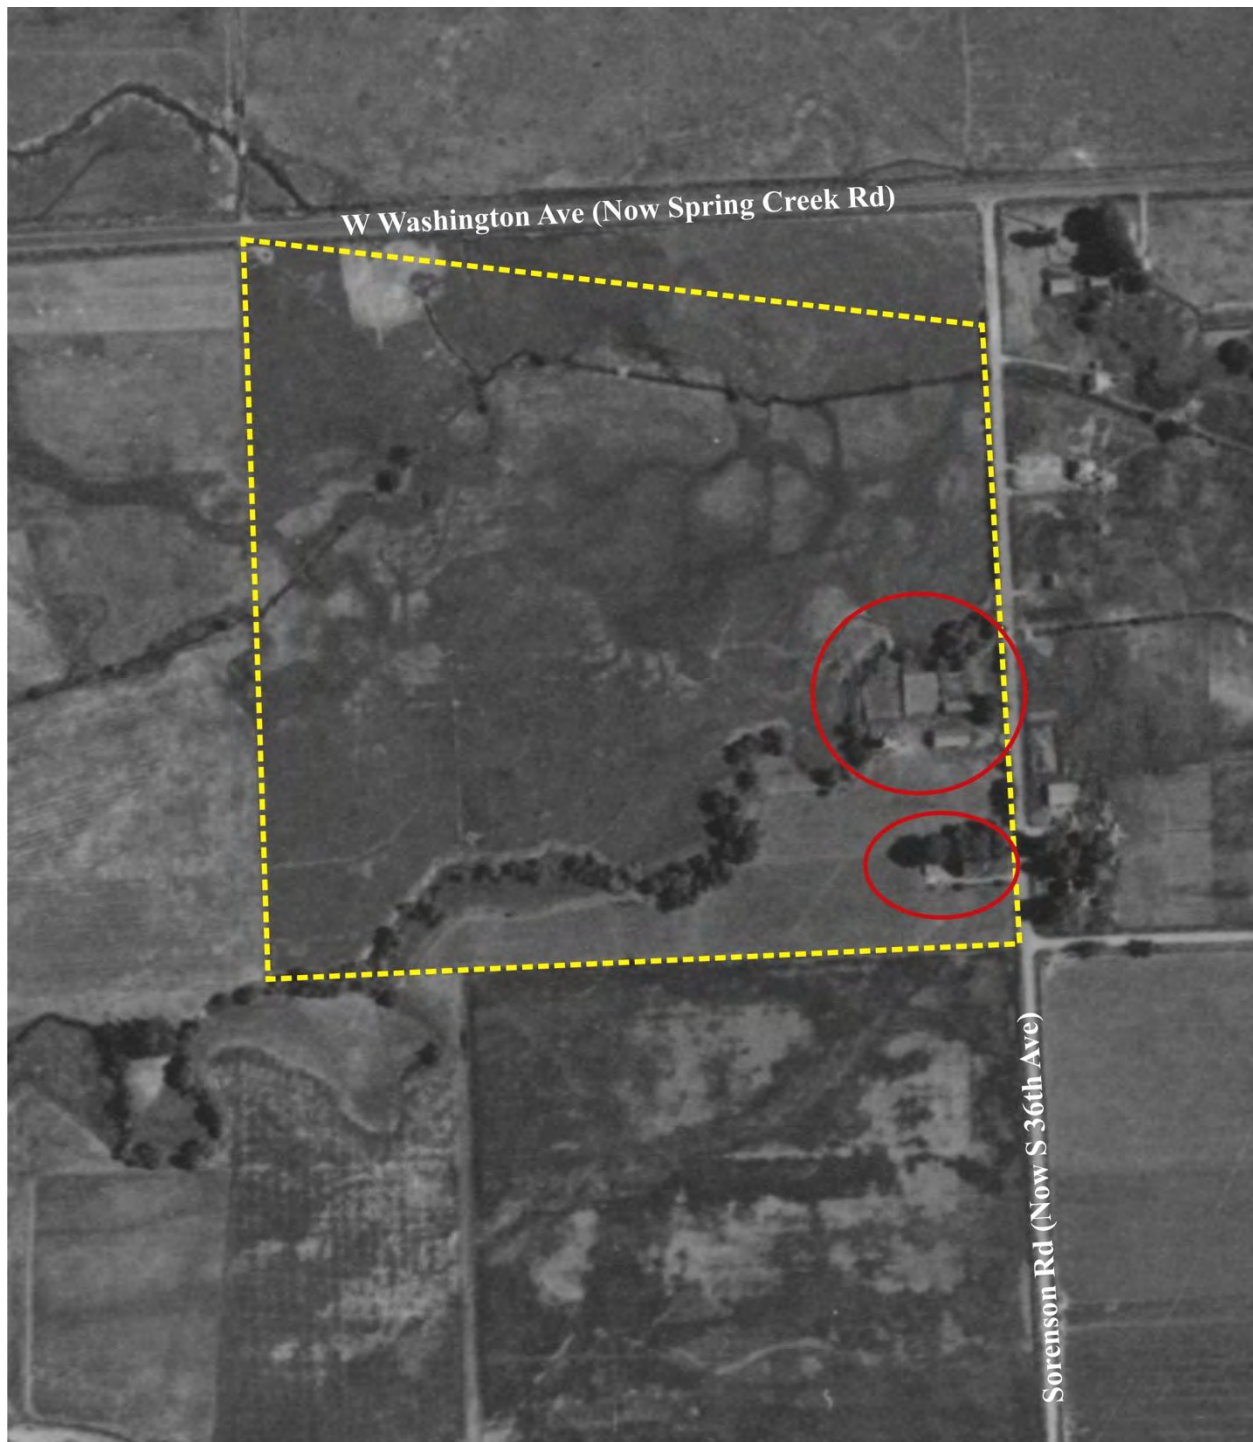
Figure 11. 1949 aerial detailing the Replacement Park Area. Note the two areas circled (in red) that appear to be the location of unidentified buildings and/or structures.

Historic aerial photography indicates that by 1949 there were several structures and/or buildings present at the southeast corner of the APE (Figure 11). At the northern half of the APE irrigation and/or water management appears to be present.

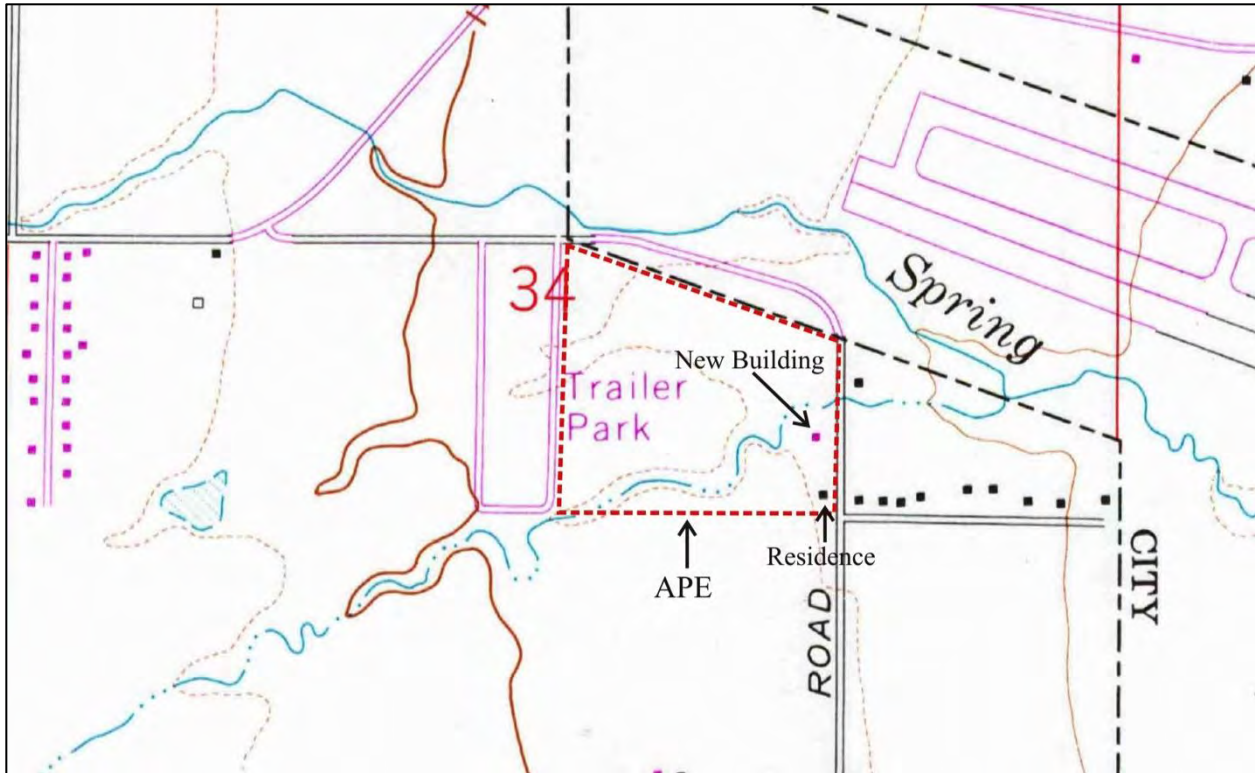
Figure 13. A portion of the 1974 USGS detailing the Replacement Park Area. Note additional building (pink) near southeast corner of APE.

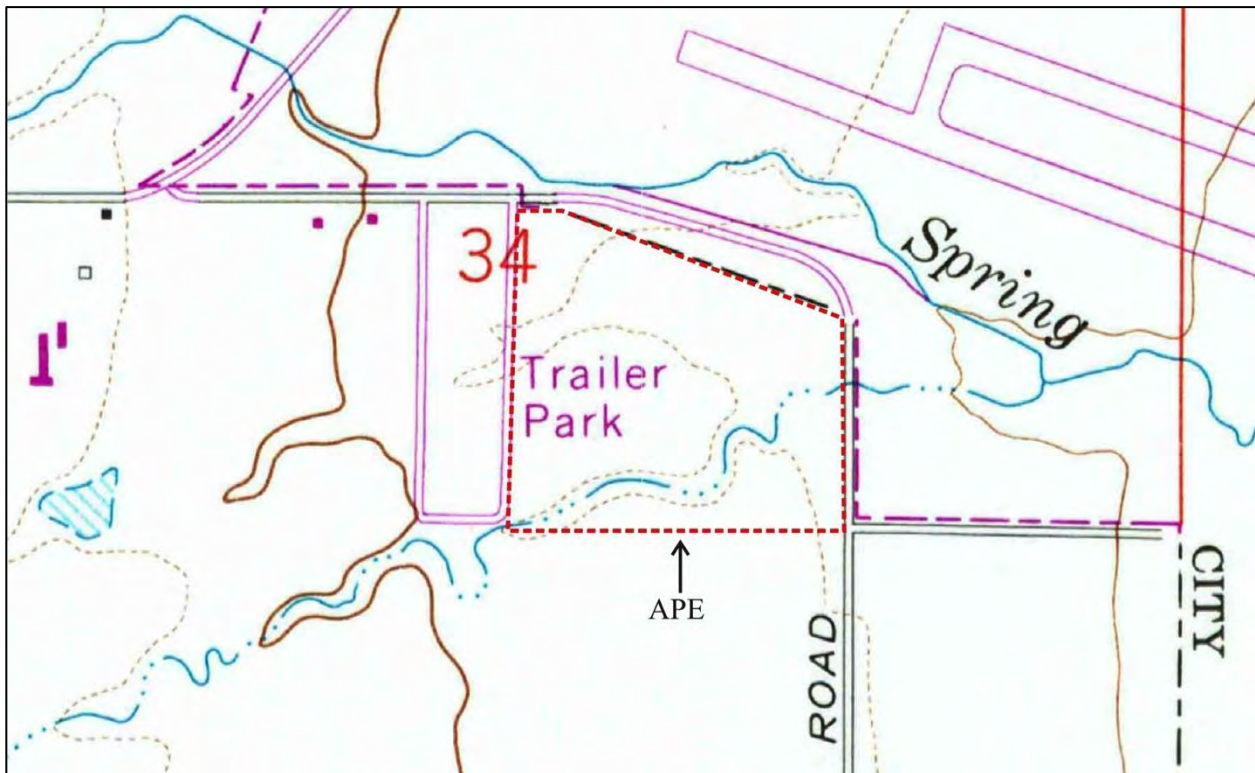
Figure 14. A portion of the 1985 USGS detailing the Replacement Park Area. Note no buildings are indicated in APE.

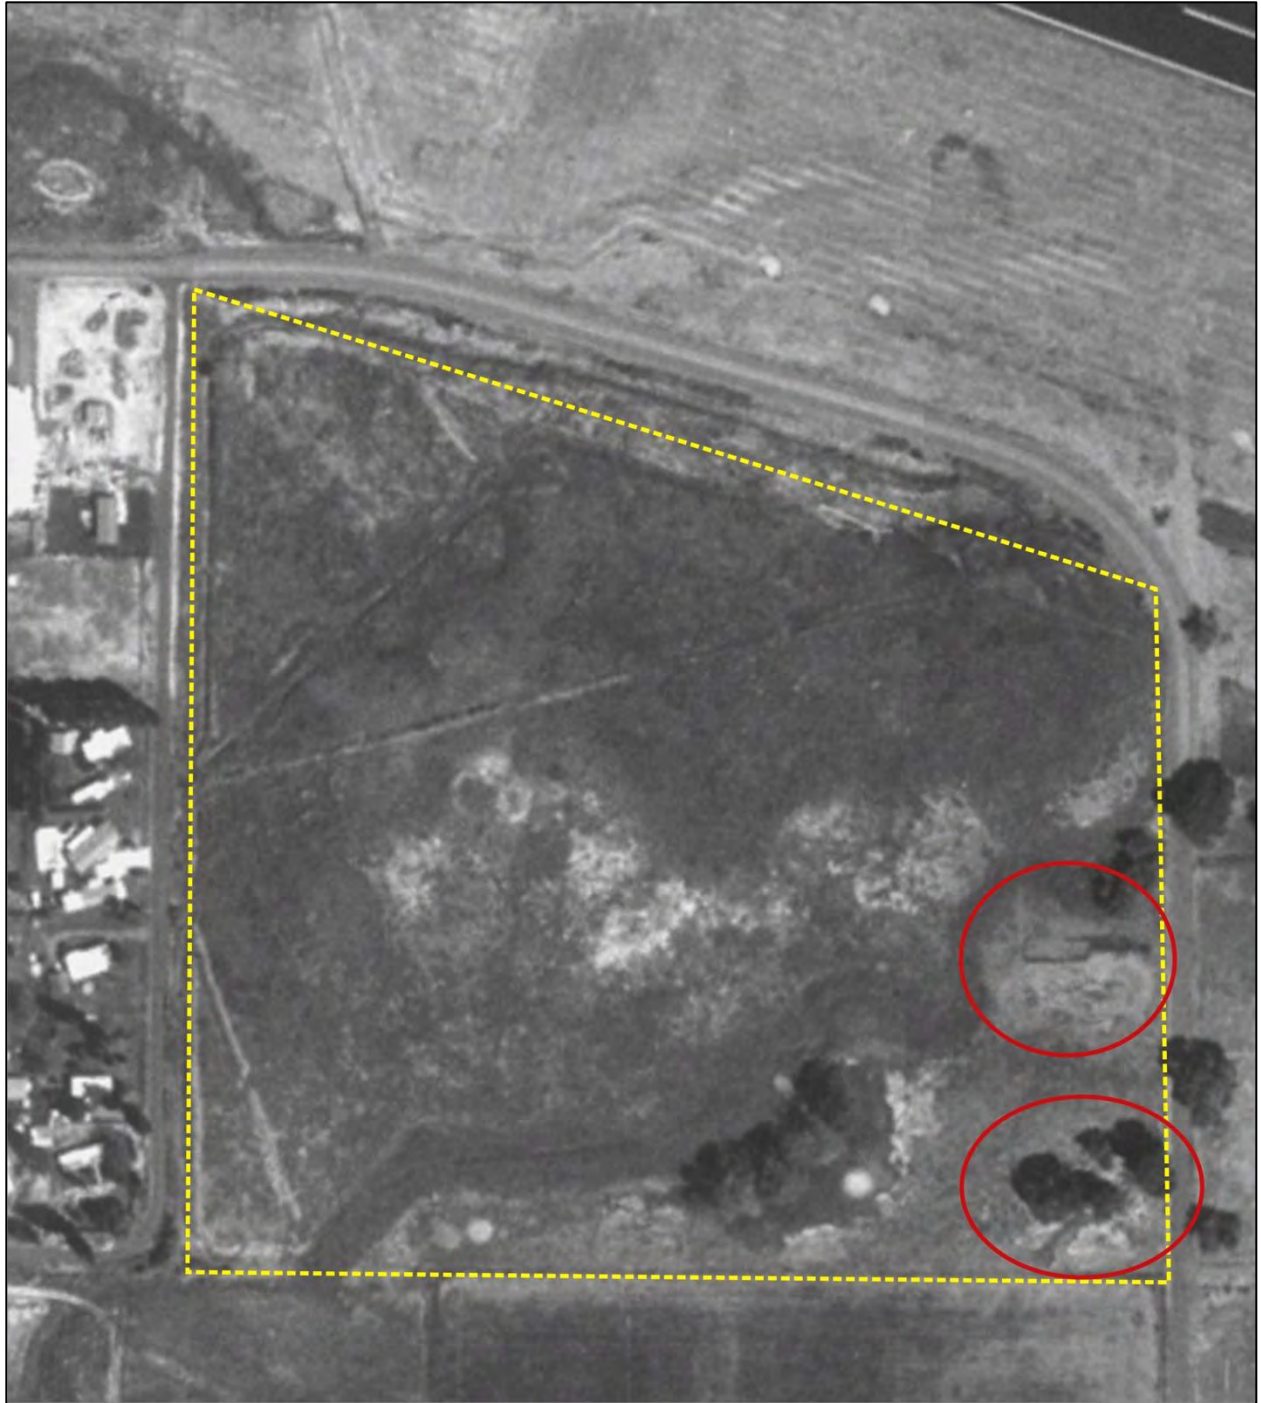
Figure 15. 1996 aerial detailing the Replacement Park Area. Note it appears that the buildings/structures near the southeast corner of the APE and much of the vegetation along Spring Creek have been removed.

that the buildings had since been demolished (Figure 14). A 1996 aerial confirms the buildings had been demolished by that time (Figure 15). According to Yakima County Assessor's Records, the property is currently owned by Congdon Development Co LLC.

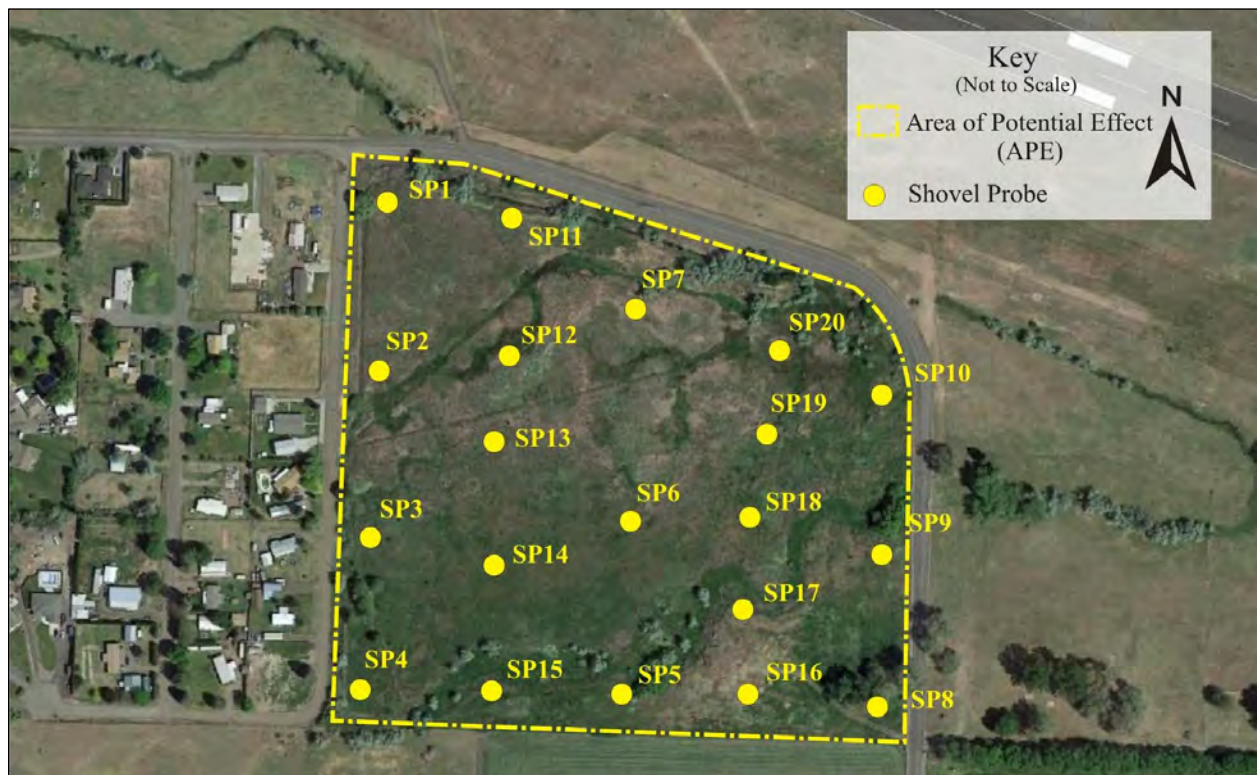
Figure 16. Location of shovel probes excavated within the Replacement Park Area.

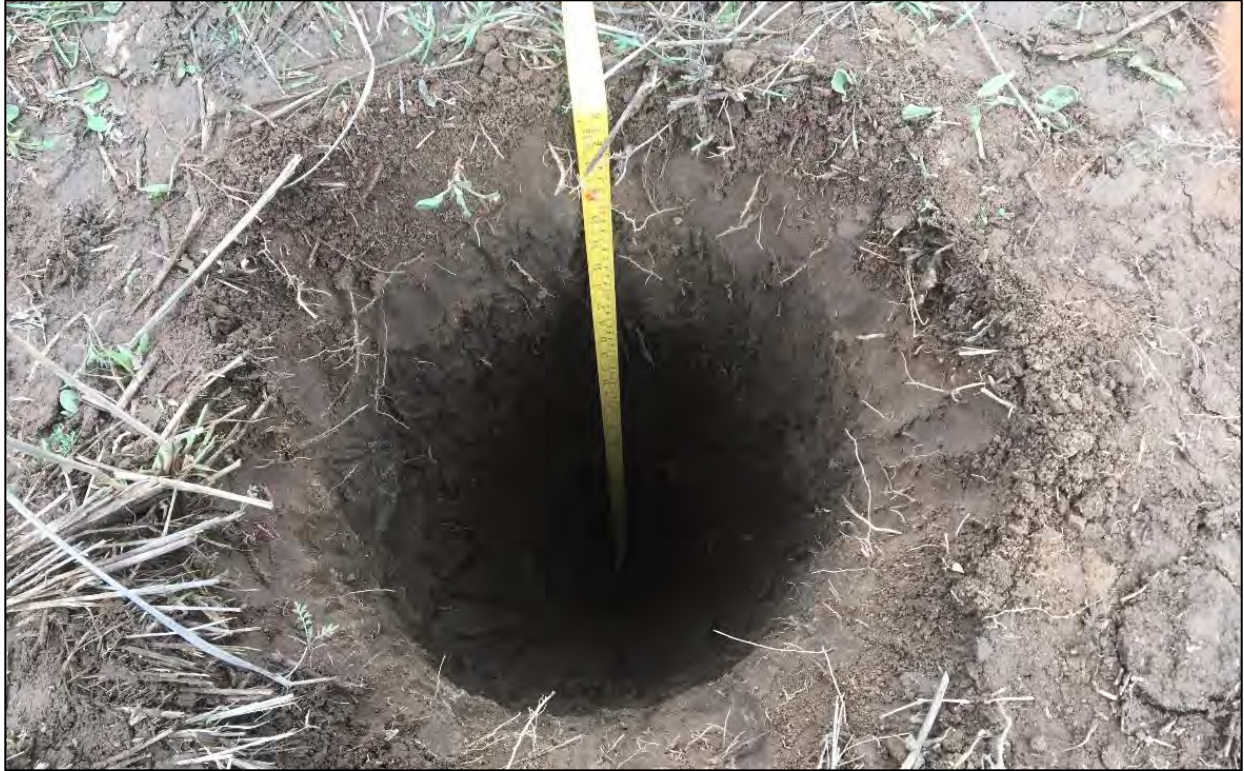
Photo 4. Shovel Probe (SP1) showing a typical sediment profile.

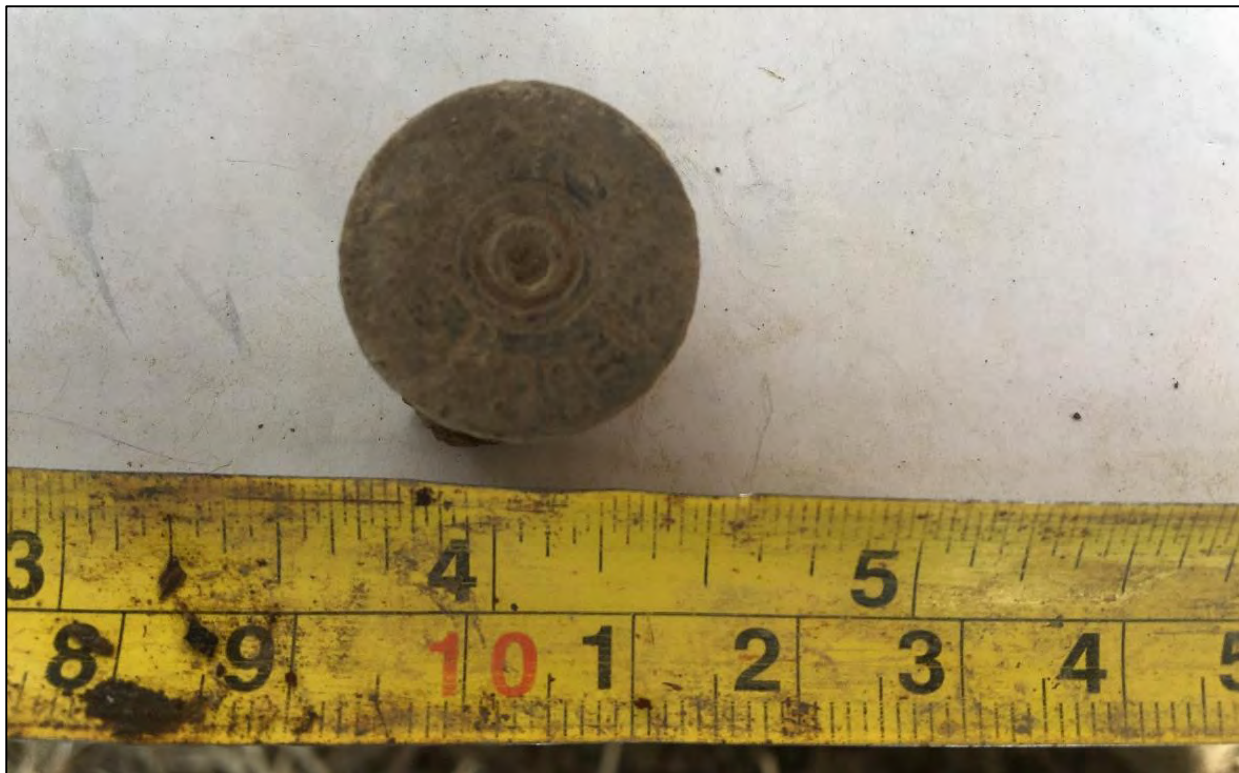
Photo 5. SP3 Shotgun shell recovered from 0-30 cmbs.

No precontact cultural materials were observed during field investigation. On the ground surface, a variety of modern and temporally non-diagnostic items such as including wooden boards, posts, a brown glass Clorox jug, beer cans, plastic of plastic, and other pieces of trash were observed. Cultural materials recovered from shovel probes consisted of one shotgun shell (Photo 5), three pieces of colorless glass, one piece of corroded iron (Photo 6), and one plastic fragment. None of these items displayed temporally diagnostic attributes.

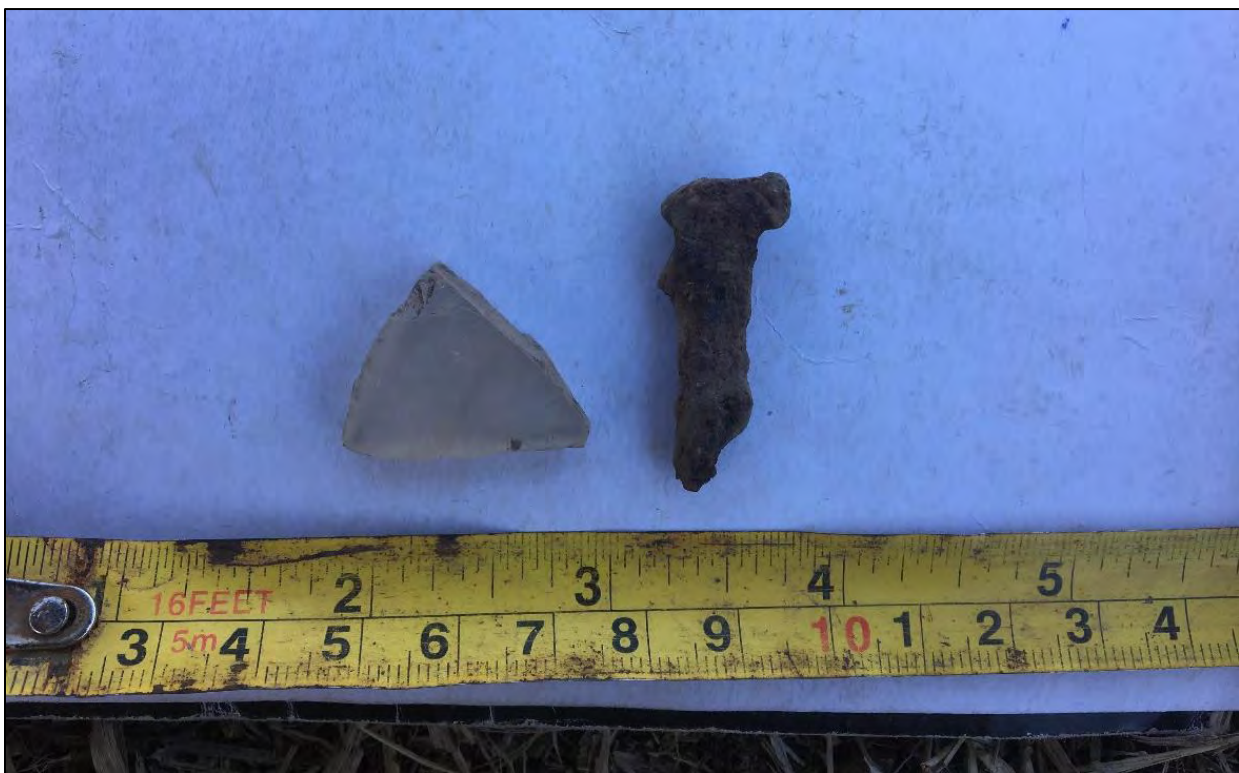
Photo 6. SP9 glass fragment and piece of corroded iron.

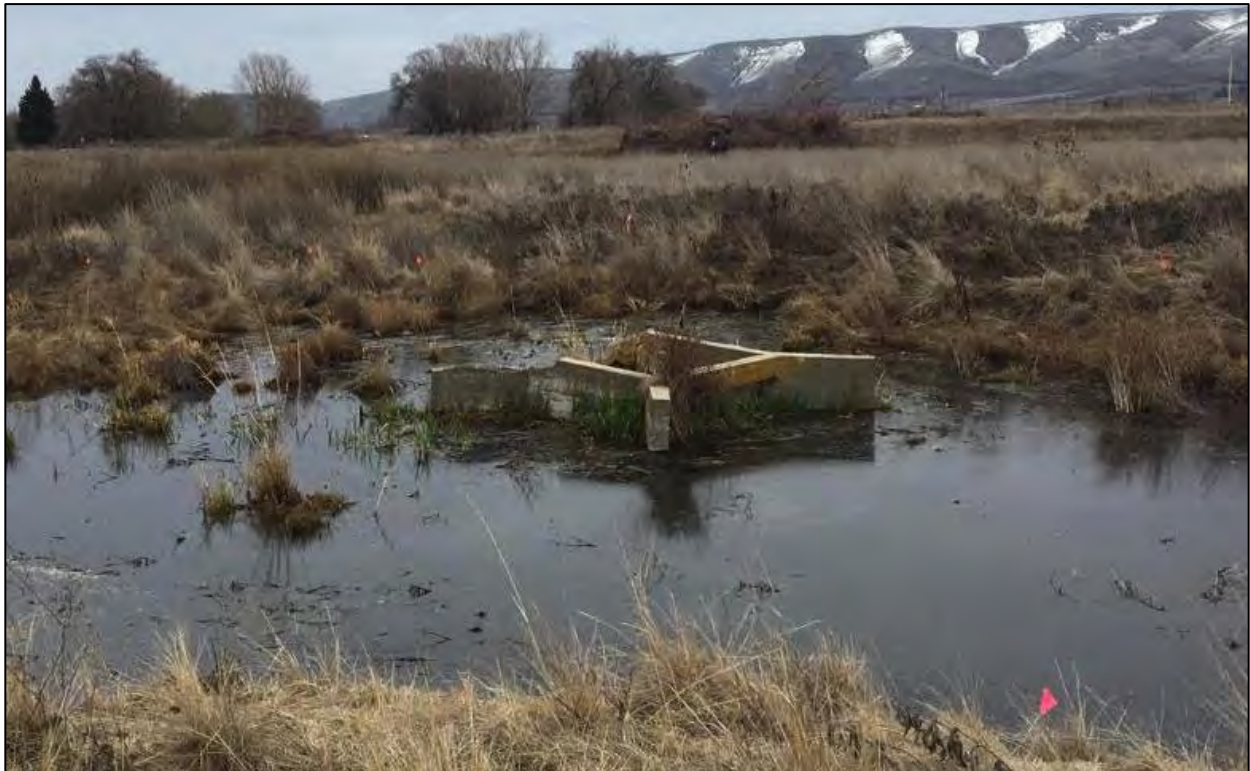
Photo 7. Concrete drainage feature encountered in the north-central portion of the Replacement Park Area.

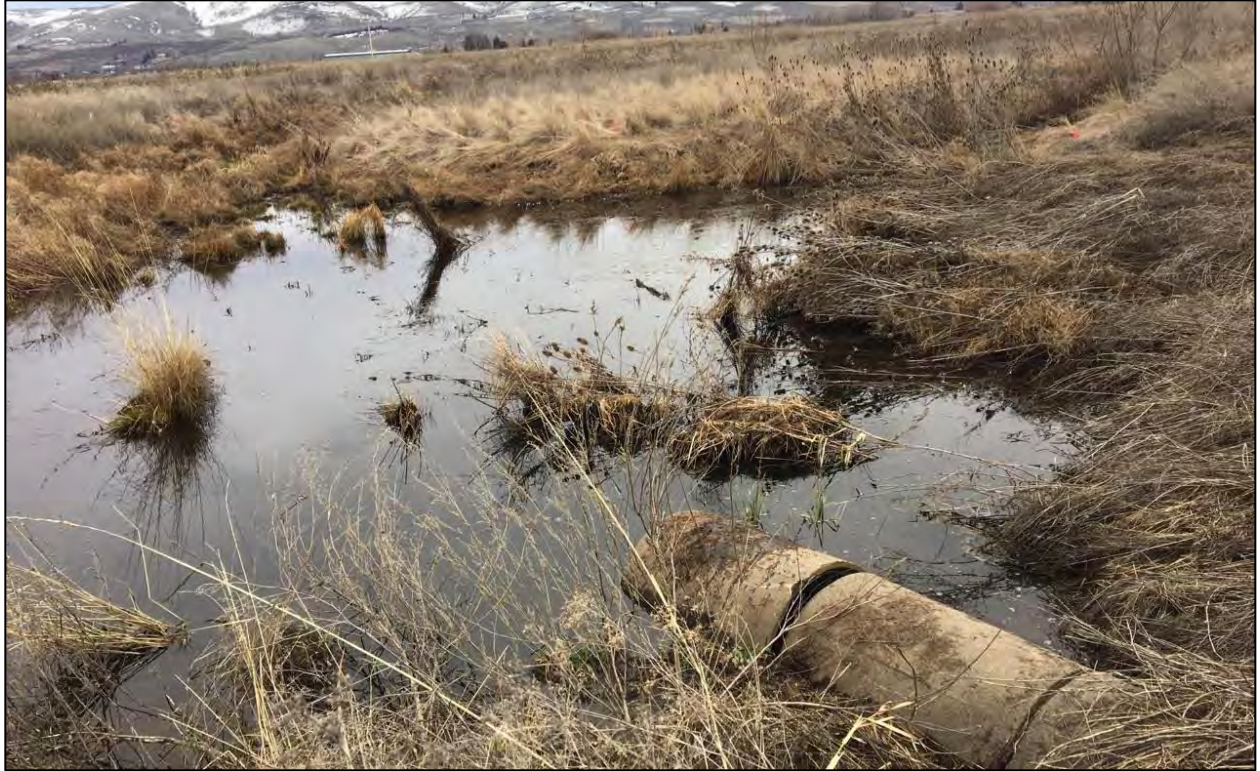
Photo 8. Concrete drainage feature encountered in the north-central portion of the Replacement Park Area.

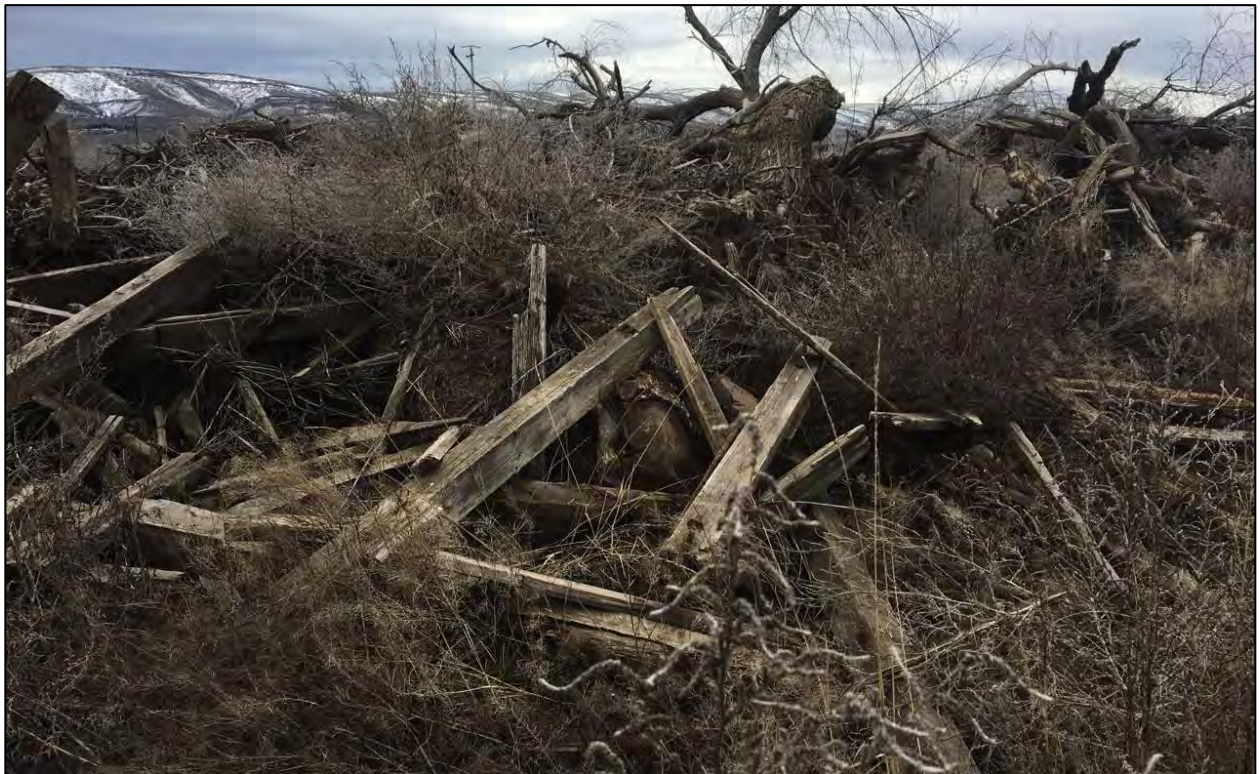
Photo 9. Overview of pile of uprooted trees and milled lumber as encountered near the southeast corner of the Replacement Park Area.

In the north-central portion of the Replacement Park Area, a concrete drainage was observed in a flooded area (Photos 7-8). The drainage was located within a linear feature that appears in the 1949 aerial. The linear feature likely functions for water management but review of documents made available by City of Yakima GIS and WISAARD did not identify the feature as part of a greater system. Additionally, piles of uprooted trees, milled lumber and associated iron fittings were observed near the southeast corner of the APE (Photo 9-10). The milled lumber appears to be mostly posts that may have been used for fencing. The piles of trees and lumber are in the vicinity of the where the former buildings and structures were located according to the reviewed historic documents. The general location of the drainage feature and piles of trees and lumber are illustrated in Figure 17.
