NEPA Environmental Assessment

RCO Conversion at Chesterley Park

A partial conversion of land protected under Section 6(f)(3) of the Land and Water Conservation Fund Act, Public Law 108-198

April 2017

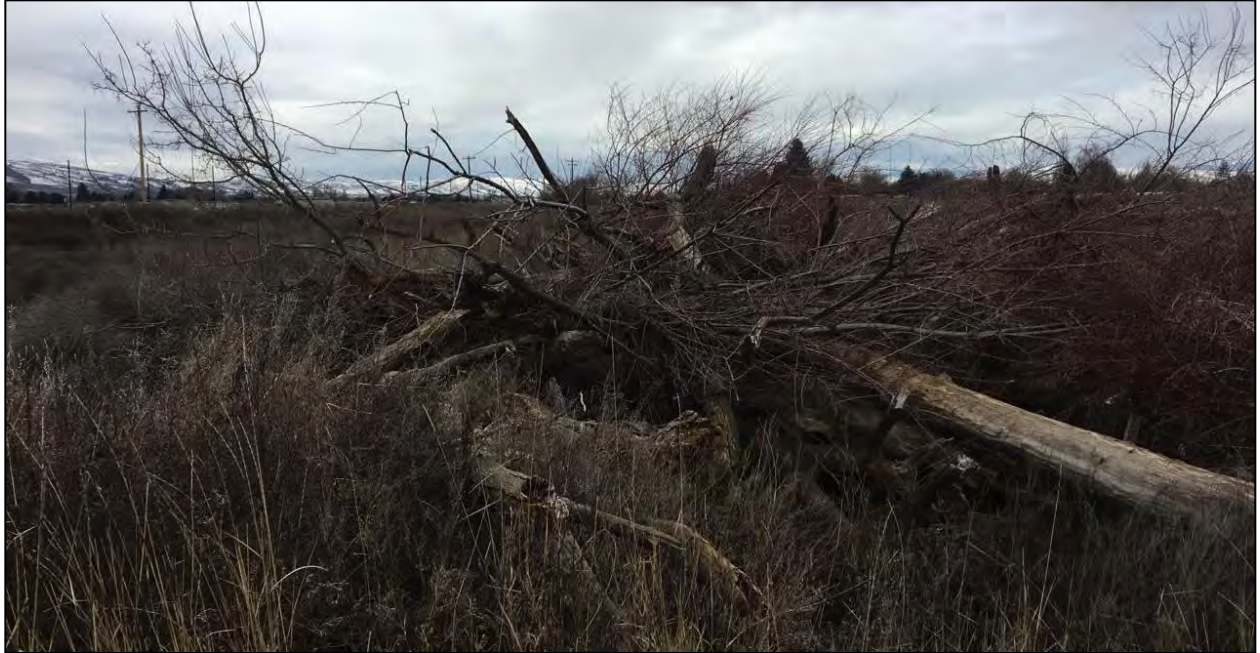
Photo 10. Overview of pile of uprooted trees as encountered near the southeast corner of the Replacement Park Area.

In the north-central portion of the Replacement Park Area, a concrete drainage was observed in a flooded area (Photos 7-8). The drainage was located within a linear feature that appears in the 1949 aerial. The linear feature likely functions for water management but review of documents made available by City of Yakima GIS and WISAARD did not identify the feature as part of a greater system. Additionally, piles of uprooted trees, milled lumber and associated iron fittings were observed near the southeast corner of the APE (Photo 9-10). The milled lumber appears to be mostly posts that may have been used for fencing. The piles of trees and lumber are in the vicinity of the where the former buildings and structures were located according to the reviewed historic documents. The general location of the drainage feature and piles of trees and lumber are illustrated in Figure 17.

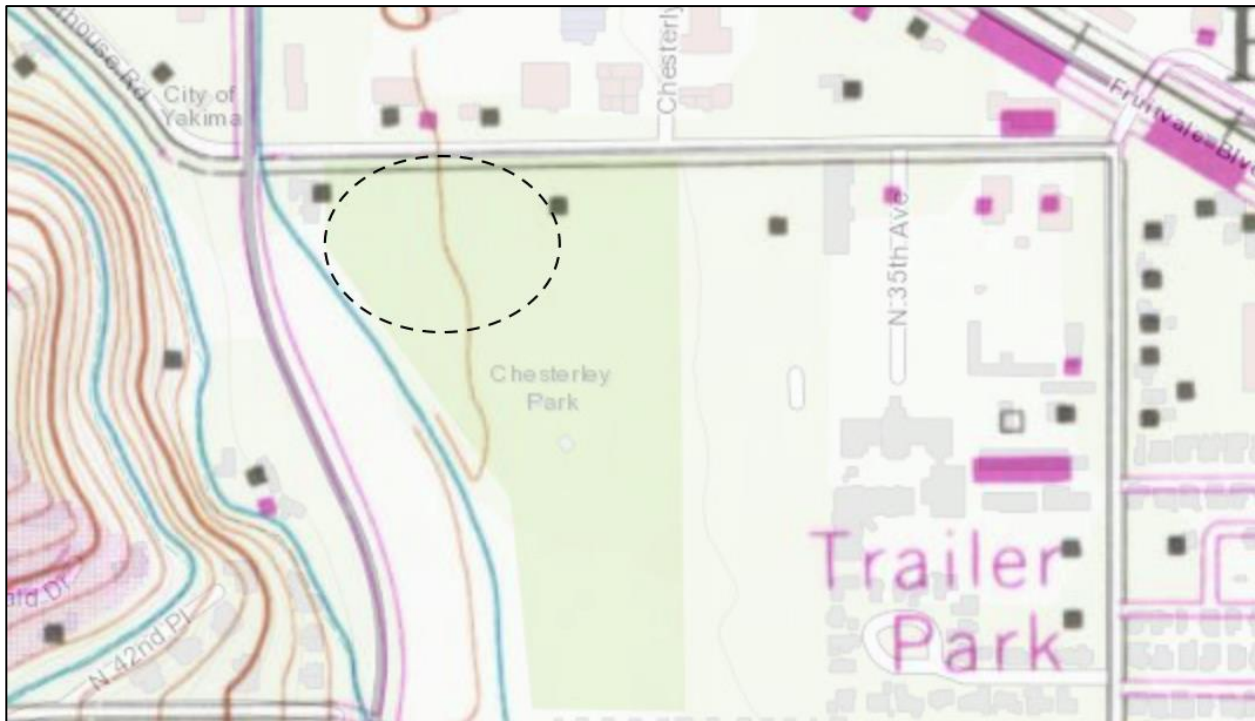
Figure 8. Portion of the 1974 USGS (overlying a contemporary map) that details the Chesterley Park Conversion Area. Note two buildings located in the northern APE are no longer present.

One of the buildings in the southeast portion of the APE was noted on the 1958 USGS topographic map (Figure 12). The USGS map was updated in 1974 and at that time another building, located nearer Spring Creek, was noted (Figure 13). This new building is located in the same location as buildings observed in the 1949 aerial. On the 1985 USGS no buildings are illustrated suggesting

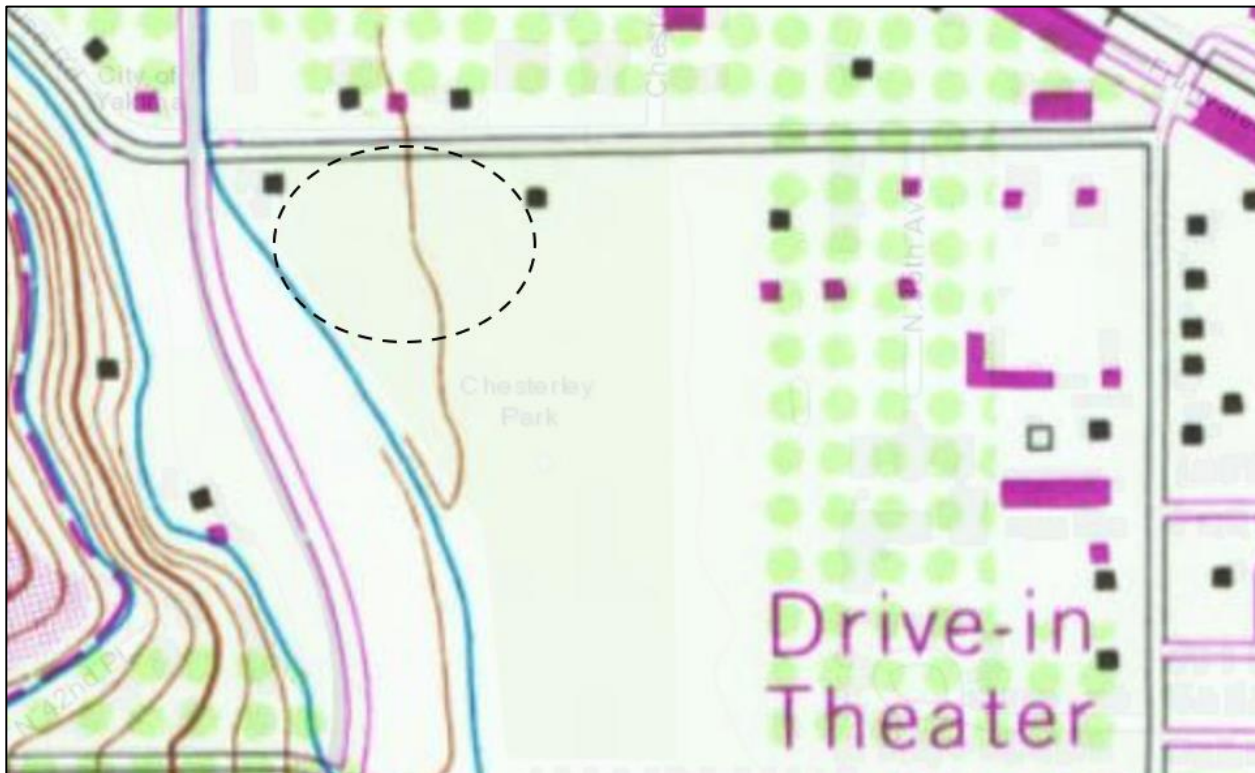
Figure 9. Portion of the 1985 USGS (overlying a contemporary map) that details the Chesterley Park Conversion Area. Note the location of buildings that are not present today.

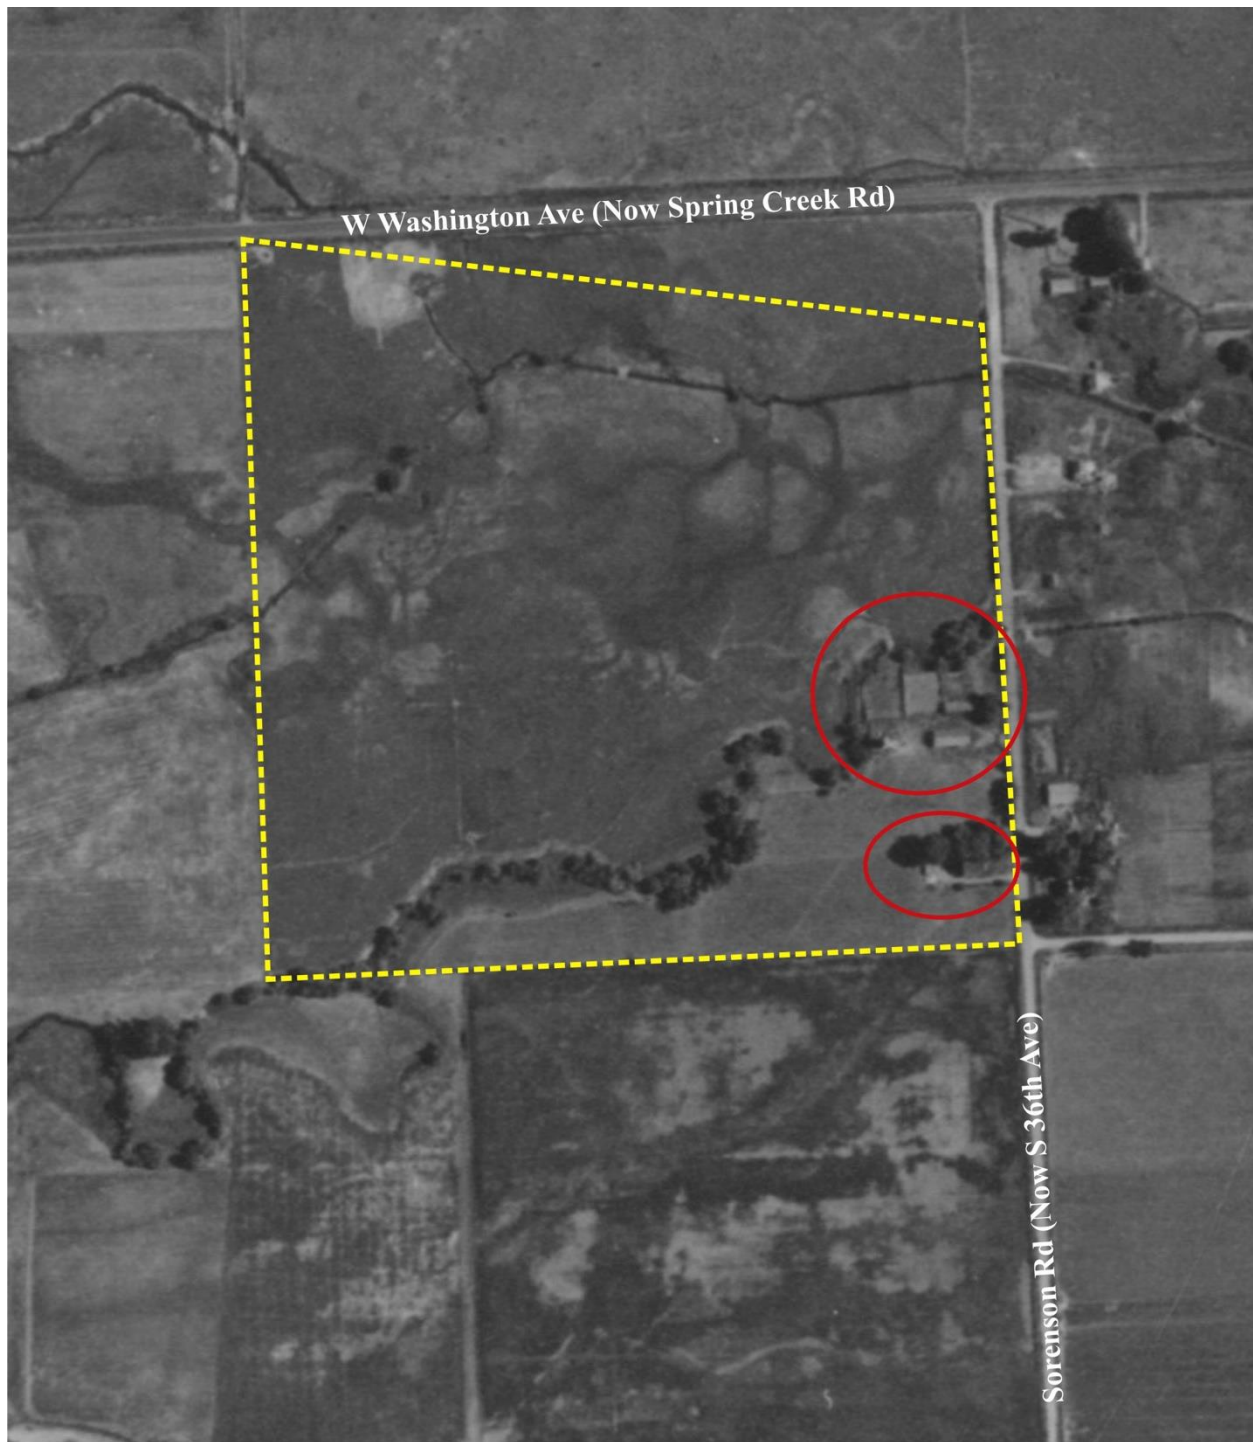
Figure 11. 1949 aerial detailing the Replacement Park Area. Note the two areas circled (in red) that appear to be the location of unidentified buildings and/or structures.

Historic aerial photography indicates that by 1949 there were several structures and/or buildings present at the southeast corner of the APE (Figure 11). At the northern half of the APE irrigation and/or water management appears to be present.

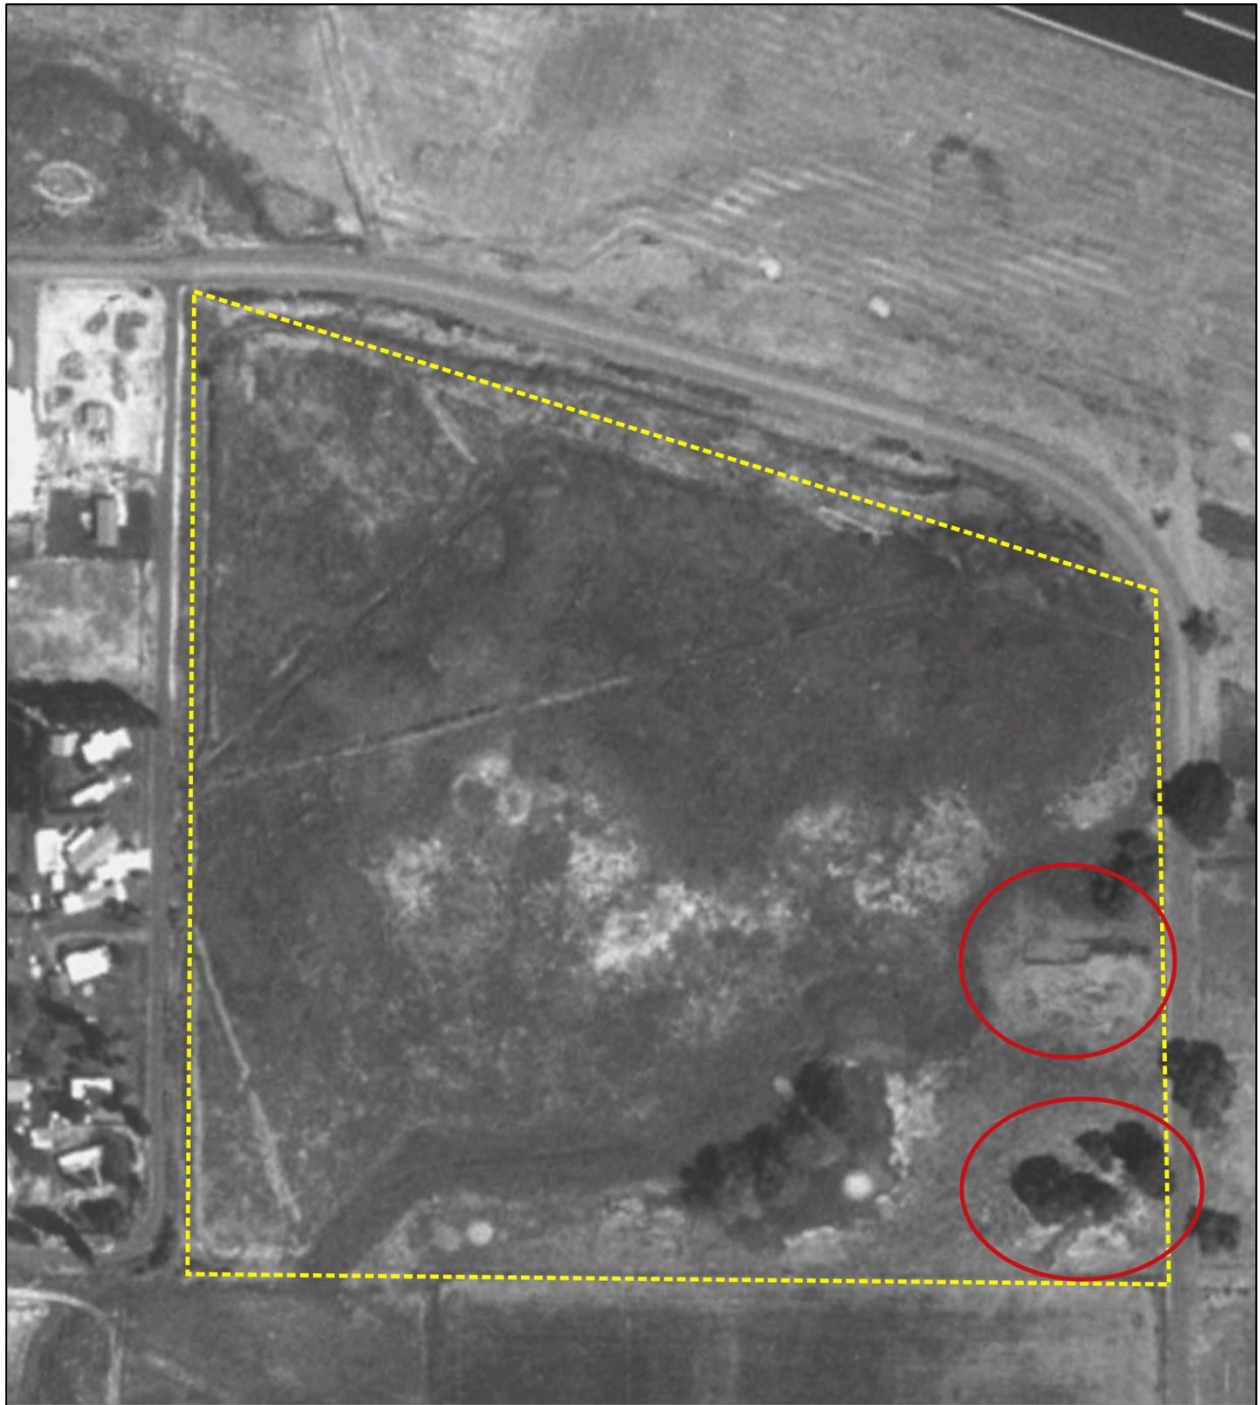
Figure 15. 1996 aerial detailing the Replacement Park Area. Note it appears that the buildings/structures near the southeast corner of the APE and much of the vegetation along Spring Creek have been removed.

that the buildings had since been demolished (Figure 14). A 1996 aerial confirms the buildings had been demolished by that time (Figure 15). According to Yakima County Assessor's Records, the property is currently owned by Congdon Development Co LLC.

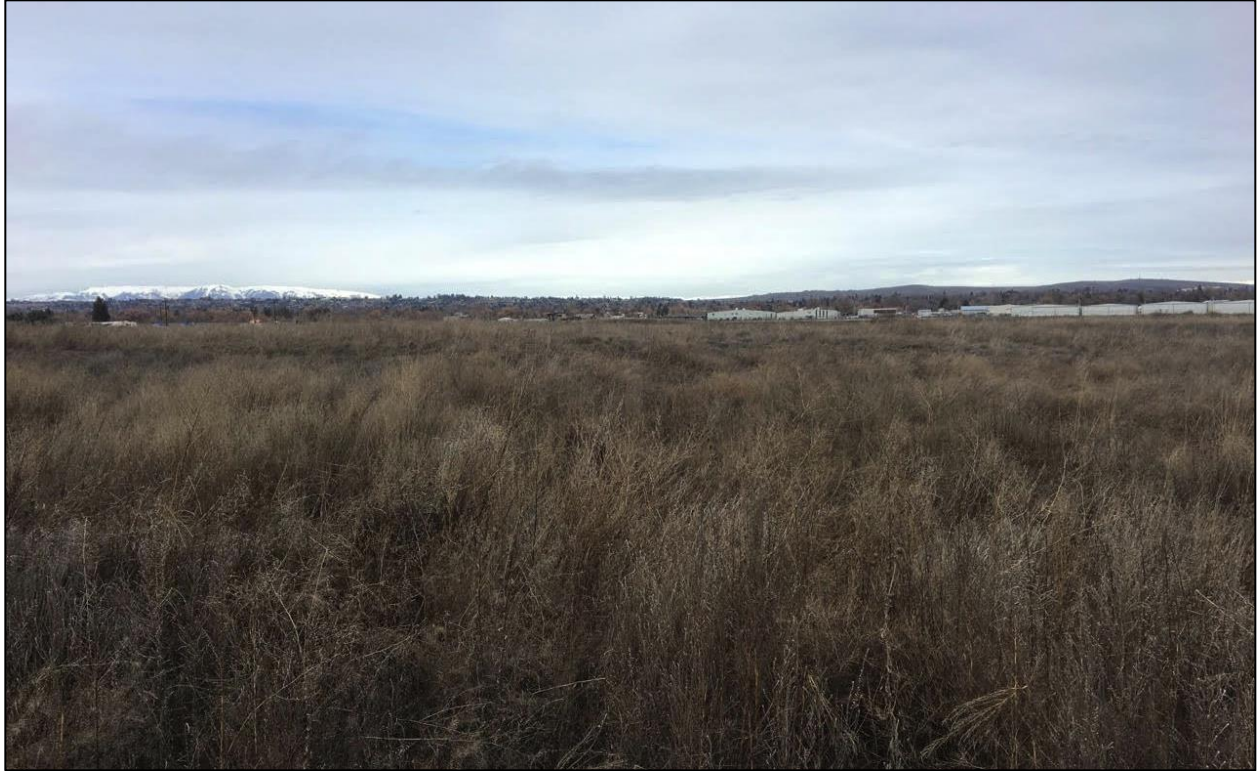
Photo 2. Overview of the Replacement Park Area, view southeast.

At the Replacement Park Area the APE is characteristic of an abandoned agricultural area. The topography is largely flat with numerous small ponds, patches of marsh, and an unnamed tributary of Spring Creek running through the southern portion of the APE (Photos 2-3). Nearly all of this section of the APE was covered by grasses and shrubs. Standard transects were impractical due to ground saturation and, as such a GPS unit was utilized to insure that the entire area was surveyed and inspected. High water and vegetation rendered ground surface visibility extremely low (less than 1 per cent).

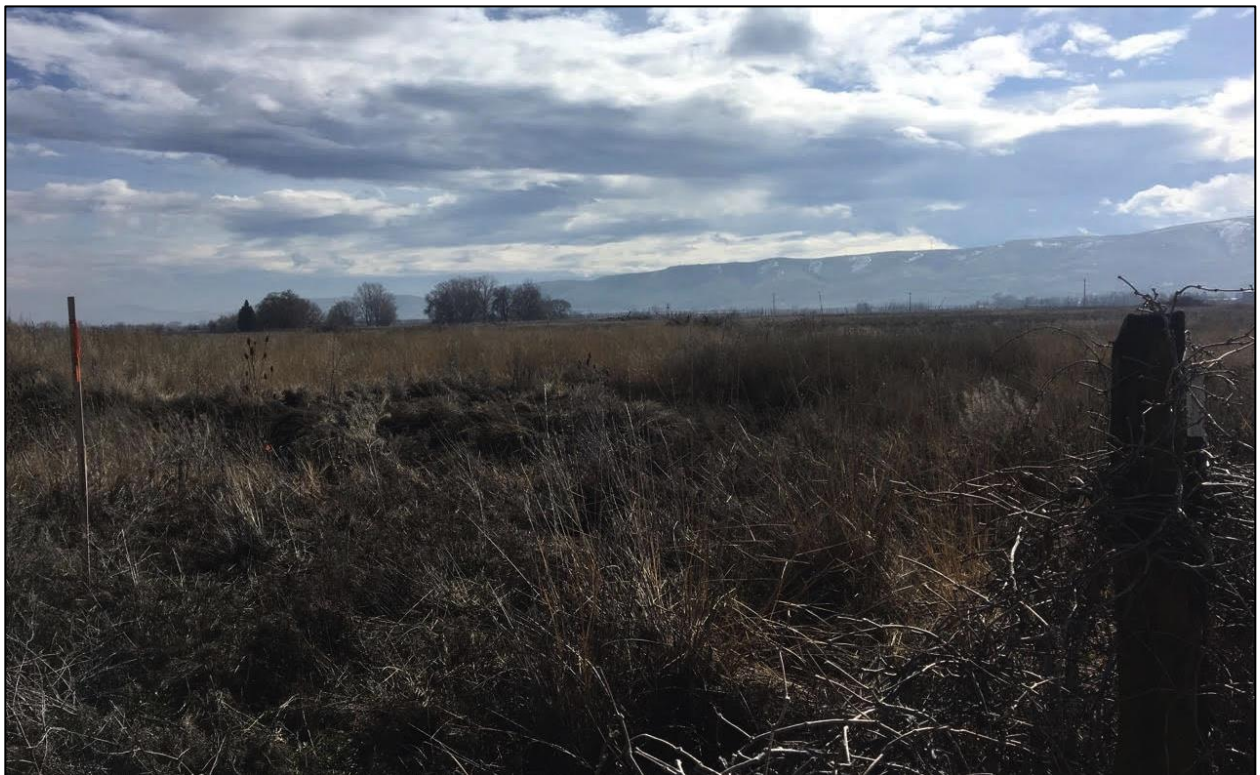
Photo 3. Overview taken from northwest corner of the Replacement Park Area, view southeast.

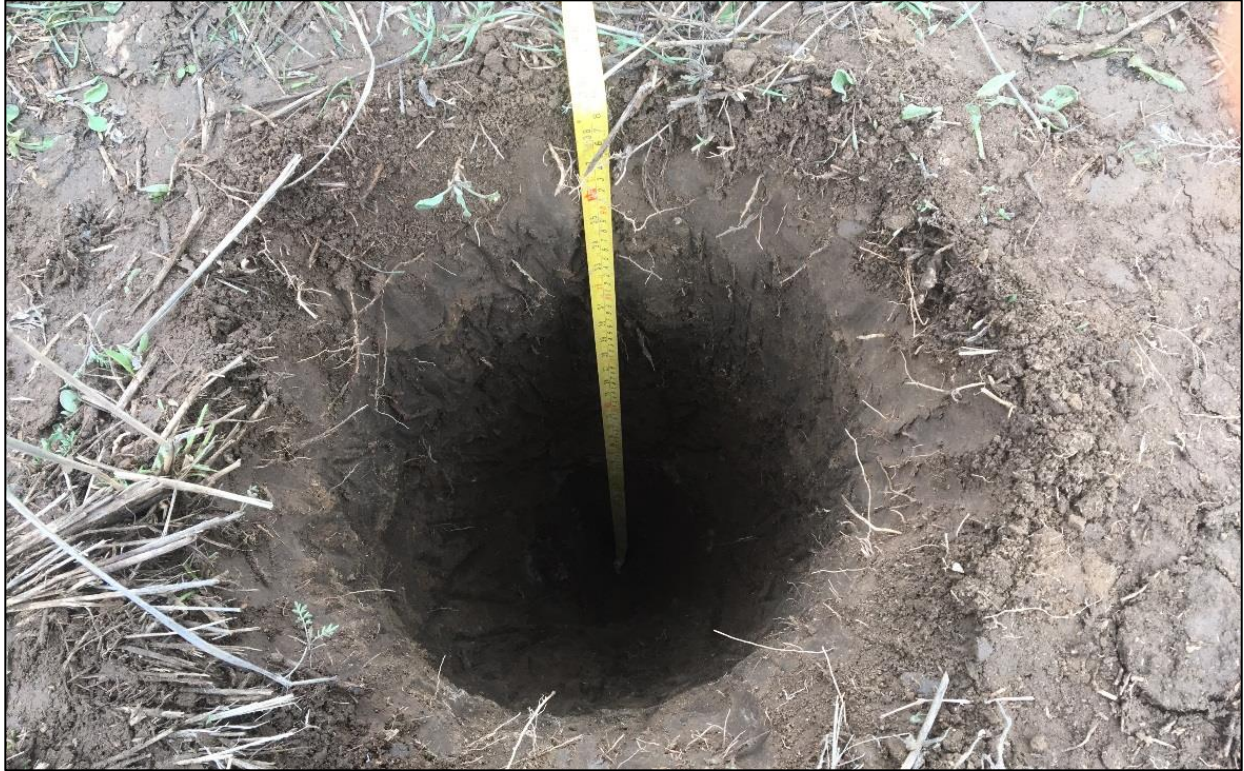
Photo 4. Shovel Probe (SP1) showing a typical sediment profile.

A total of 20 shovel probes were excavated at the Replacement Park Area (Figure 16). Shovel probes were oriented along north-south running transect lines, with transect lines spaced 90 meters apart. The number of shovel probes corresponding to each transect line varied from three to five shovel probes, with probes evenly spaced from project areas southern and northern boundaries. Observed sediments consisted of loosely-to-moderately compact silty loam ranging in color from dark brown to yellow brown with little to no discernable stratigraphy. Rock content was extremely low throughout the project area (Photo 4).

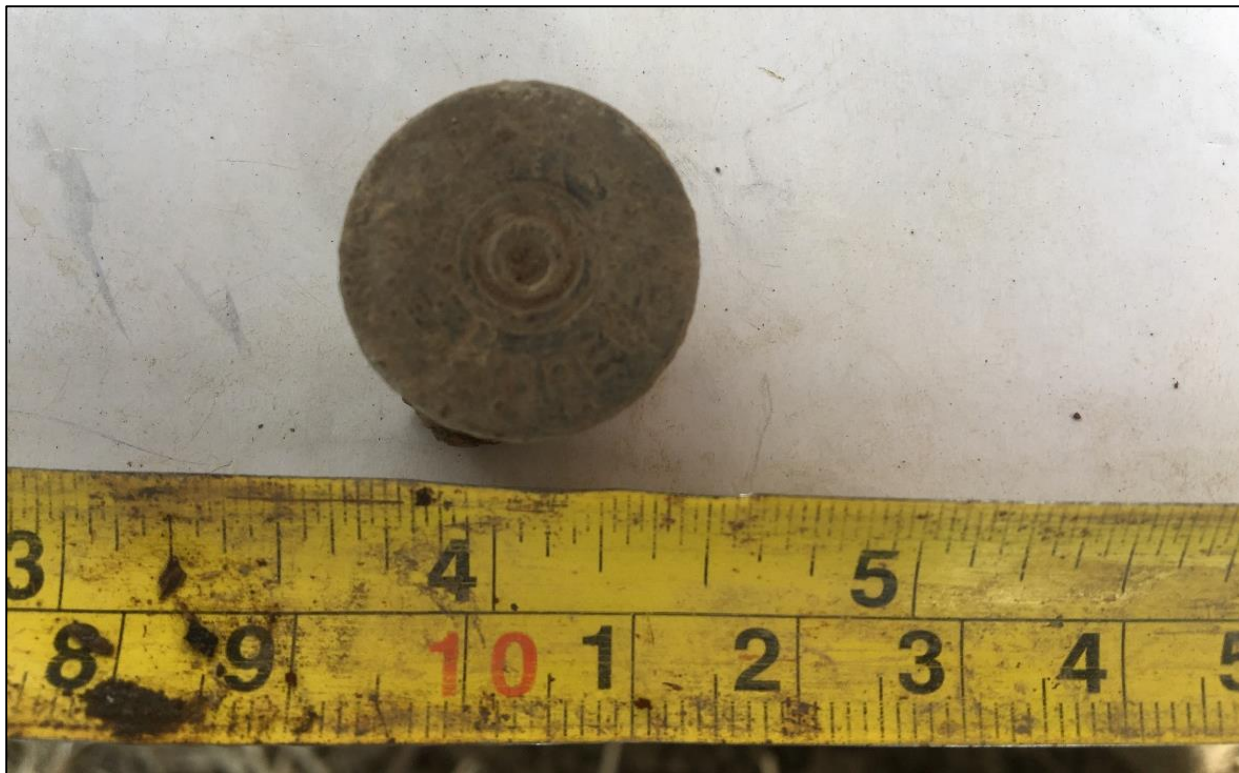
Photo 5. SP3 Shotgun shell recovered from 0-30 cmbs.

No precontact cultural materials were observed during field investigation. On the ground surface, a variety of modern and temporally non-diagnostic items such as including wooden boards, posts, a brown glass Clorox jug, beer cans, plastic of plastic, and other pieces of trash were observed. Cultural materials recovered from shovel probes consisted of one shotgun shell (Photo 5), three pieces of colorless glass, one piece of corroded iron (Photo 6), and one plastic fragment. None of these items displayed temporally diagnostic attributes.

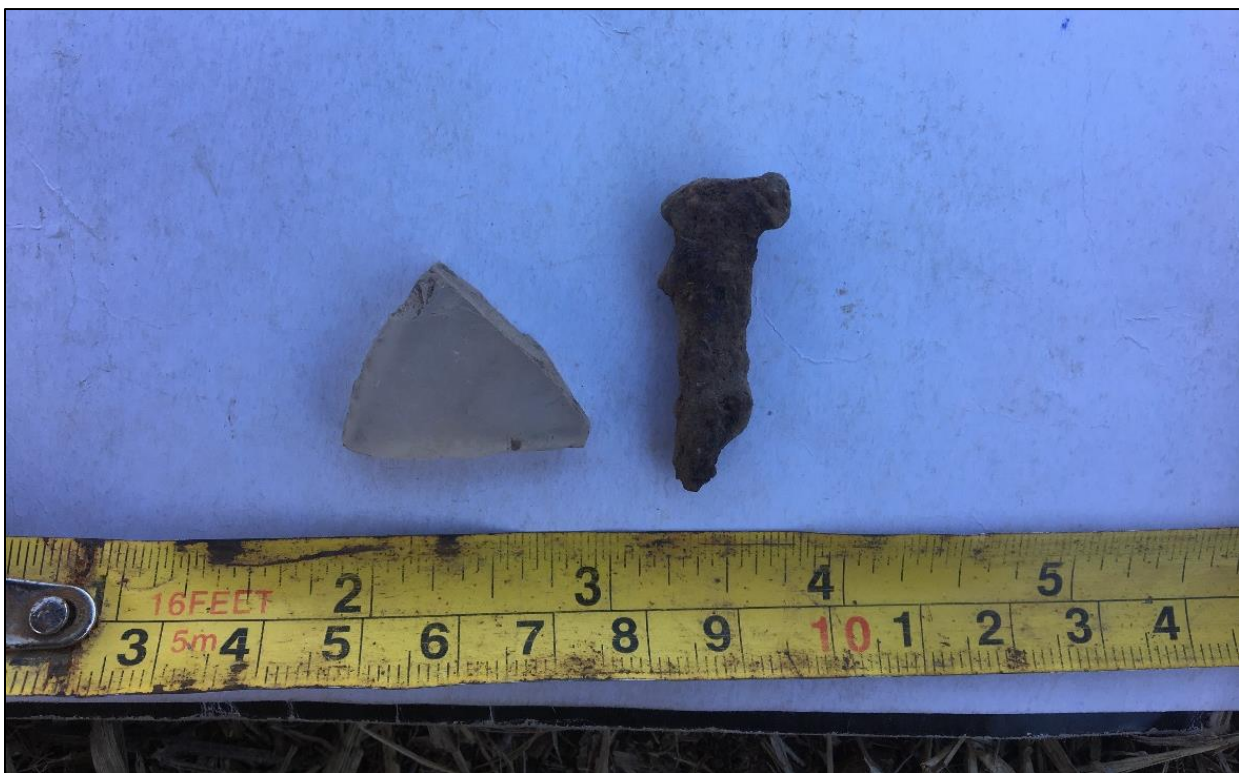
Photo 6. SP9 glass fragment and piece of corroded iron.

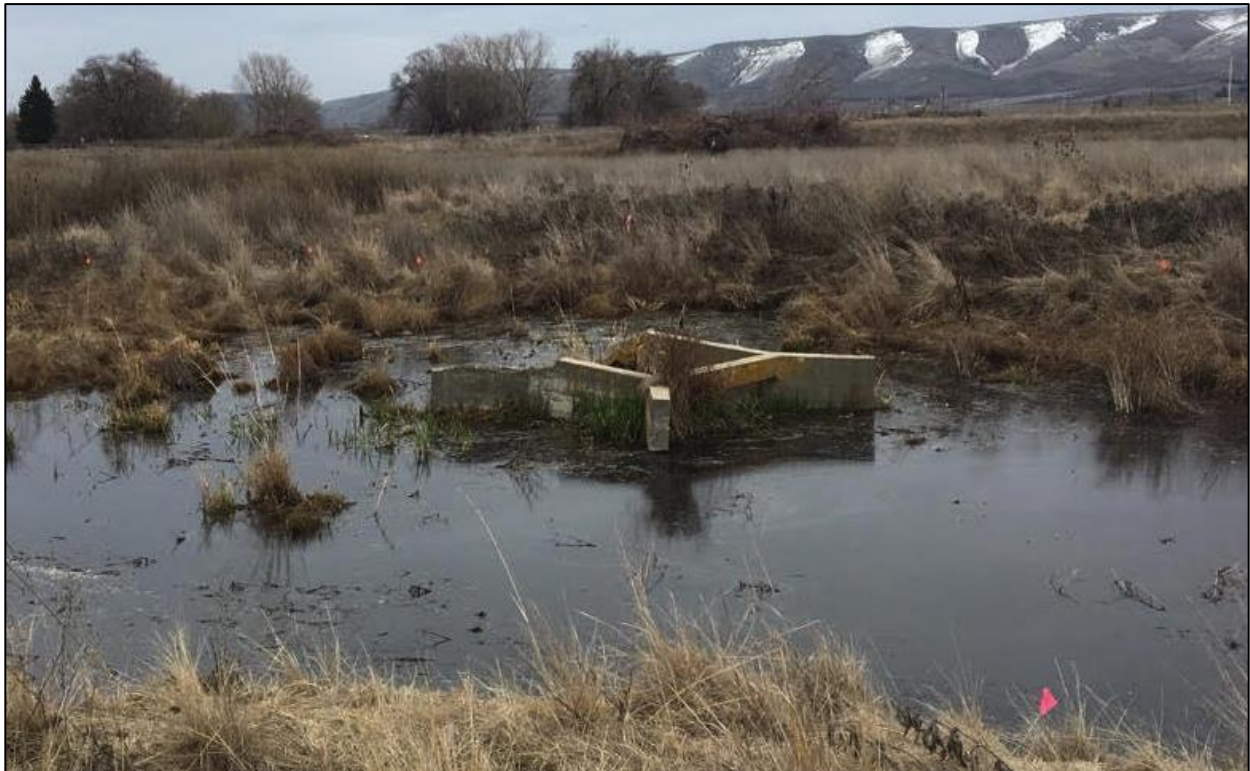
Photo 7. Concrete drainage feature encountered in the north-central portion of the Replacement Park Area.

In the north-central portion of the Replacement Park Area, a concrete drainage was observed in a flooded area (Photos 7-8). The drainage was located within a linear feature that appears in the 1949 aerial. The linear feature likely functions for water management but review of documents made available by City of Yakima GIS and WISAARD did not identify the feature as part of a greater system. Additionally, piles of uprooted trees, milled lumber and associated iron fittings were observed near the southeast corner of the APE (Photo 9-10). The milled lumber appears to be mostly posts that may have been used for fencing. The piles of trees and lumber are in the vicinity of the where the former buildings and structures were located according to the reviewed historic documents. The general location of the drainage feature and piles of trees and lumber are illustrated in Figure 17.

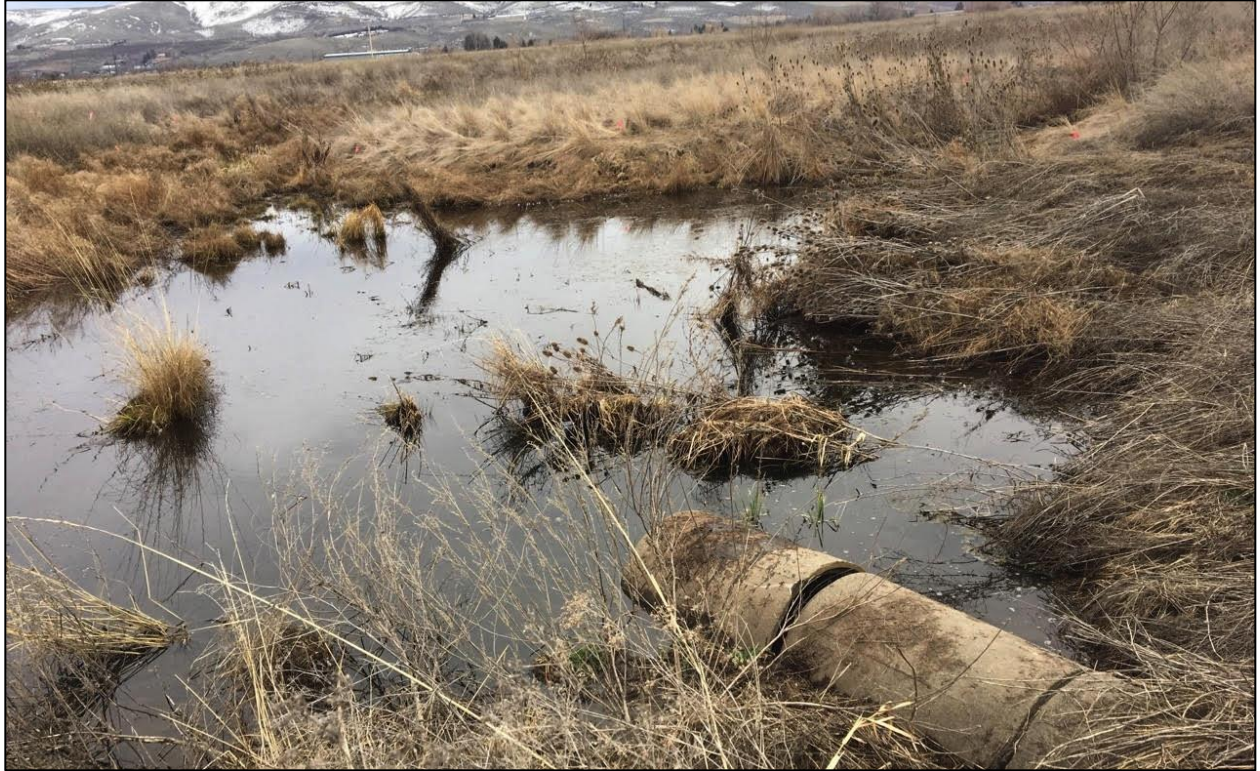
Photo 8. Concrete drainage feature encountered in the north-central portion of the Replacement Park Area.

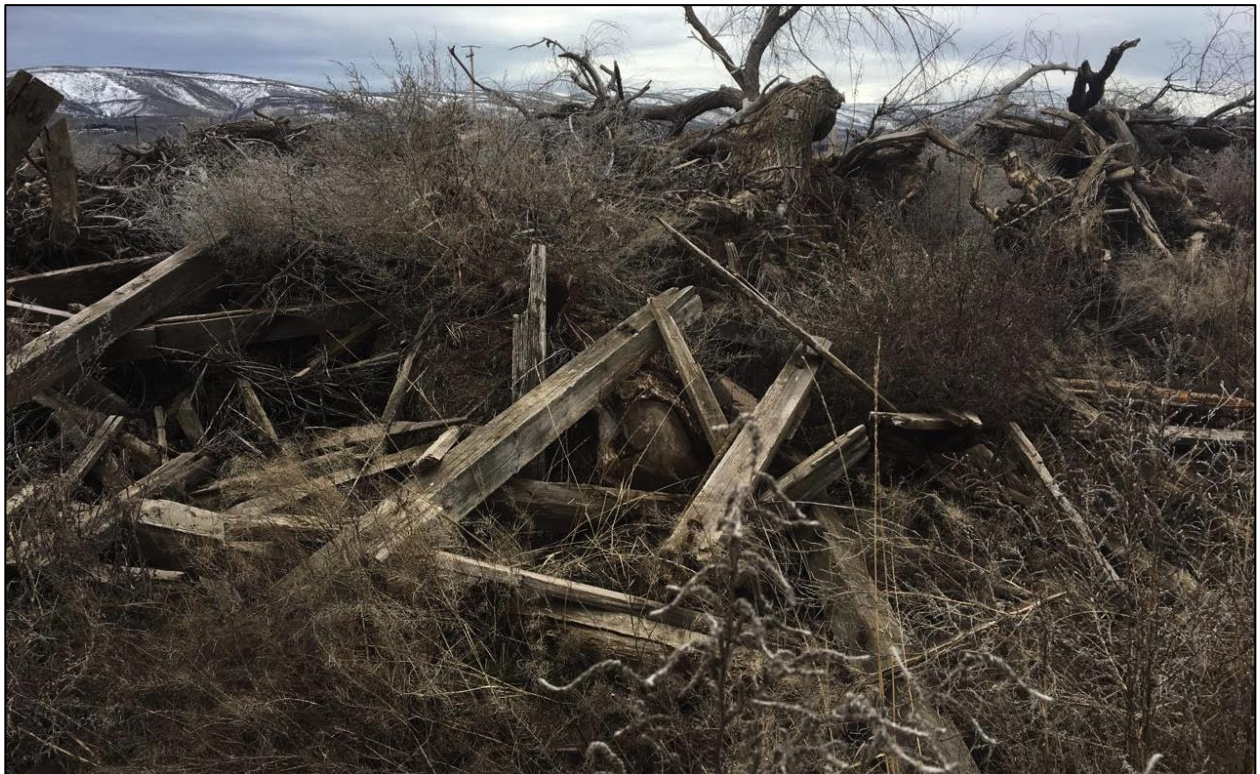
Photo 9. Overview of pile of uprooted trees and milled lumber as encountered near the southeast corner of the Replacement Park Area.

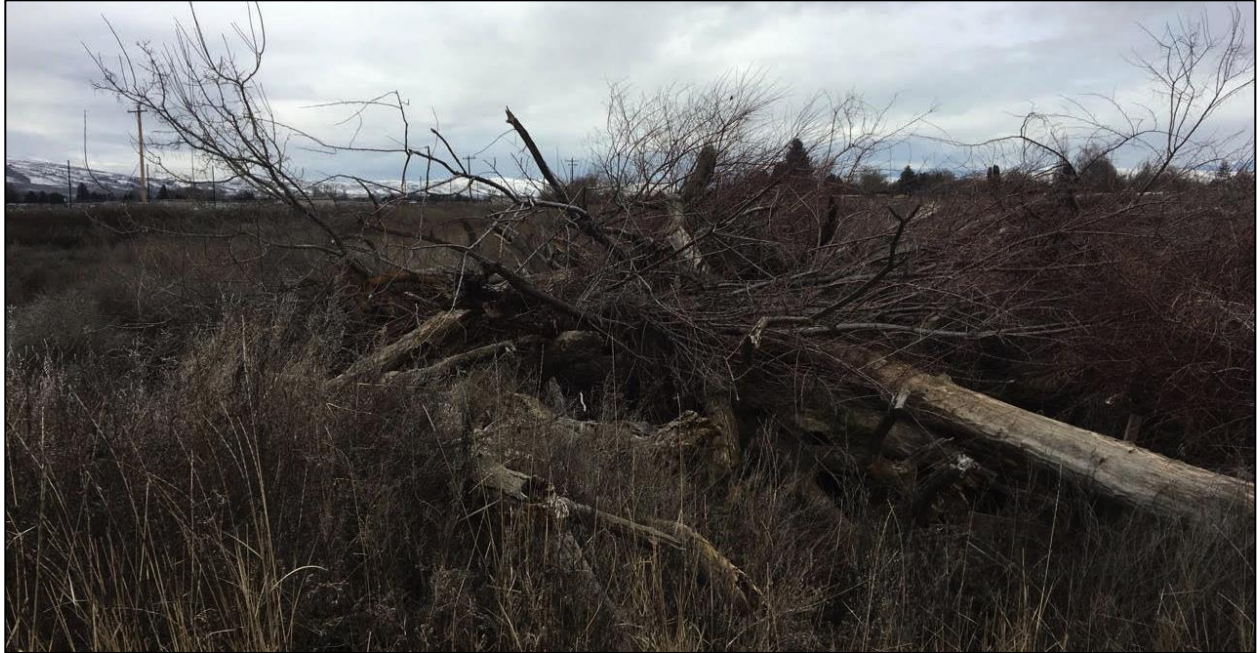
Photo 10. Overview of pile of uprooted trees as encountered near the southeast corner of the Replacement Park Area.
